Quality Assurance and Source Inspection

Contract #: 04-0120F4Cty: SF/ALA Rte: 80 PM: 13.2/13.9File #: 1.28**WELDING INSPECTION REPORT****Resident Engineer:** Siegenthaler, Peter**Address:** 333 Burma Road**City:** Oakland, CA 94607**Report No:** WIR-023181**Date Inspected:** 29-Apr-2011**Project Name:** SAS Superstructure**OSM Arrival Time:** 700**Prime Contractor:** American Bridge/Fluor Enterprises, a JV**OSM Departure Time:** 1530**Contractor:** American Bridge/Fluor Enterprises, a JV**Location:** Job Site**CWI Name:** See Report Below**CWI Present:** Yes No**Inspected CWI report:** Yes No N/A**Rod Oven in Use:** Yes No N/A**Electrode to specification:** Yes No N/A**Weld Procedures Followed:** Yes No N/A**Qualified Welders:** Yes No N/A**Verified Joint Fit-up:** Yes No N/A**Approved Drawings:** Yes No N/A**Approved WPS:** Yes No N/A**Delayed / Cancelled:** Yes No N/A**Bridge No:** 34-0006**Component:** Orthotropic Box Girders**Summary of Items Observed:**

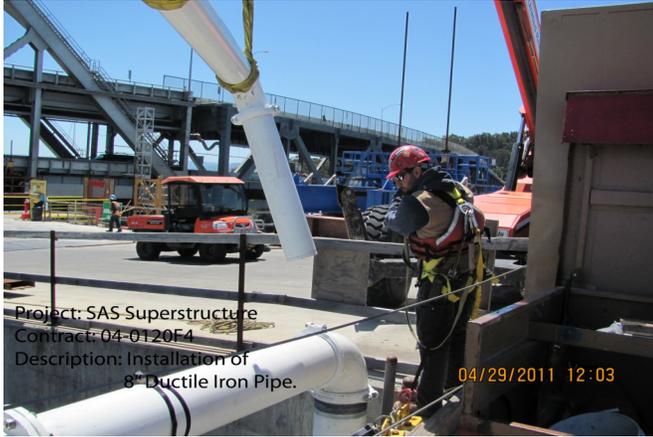
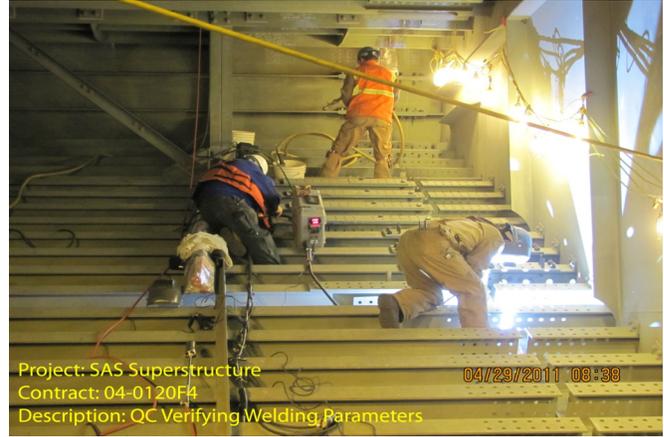
The digital photographs on page 3 of this report illustrate some of the related work activities observed during this scheduled shift.
