Contract #: 04-0120F4Cty: SF/ALA Rte: 80 PM: 13.2/13.9File #: 99.28**WELDING INSPECTION REPORT****Resident Engineer:** Siegenthaler, Peter**Address:** 333 Burma Road**City:** Oakland, CA 94607**Report No:** WIR-023187**Date Inspected:** 28-Apr-2011**Project Name:** SAS Superstructure**OSM Arrival Time:** 700**Prime Contractor:** American Bridge/Fluor Enterprises, a JV**OSM Departure Time:** 1900**Contractor:** Zhenhua Port Machinery Company, Ltd (ZPMC) Chanxing Island**Location:** Shanghai, China**CWI Name:** Mr. Sun Tian Liang**CWI Present:** Yes No**Inspected CWI report:** Yes No N/A**Rod Oven in Use:** Yes No N/A**Electrode to specification:** Yes No N/A**Weld Procedures Followed:** Yes No N/A**Qualified Welders:** Yes No N/A**Verified Joint Fit-up:** Yes No N/A**Approved Drawings:** Yes No N/A**Approved WPS:** Yes No N/A**Delayed / Cancelled:** Yes No N/A**Bridge No:** 34-0006**Component:** OBG Segment**Summary of Items Observed:**

WELDING INSPECTION REPORT

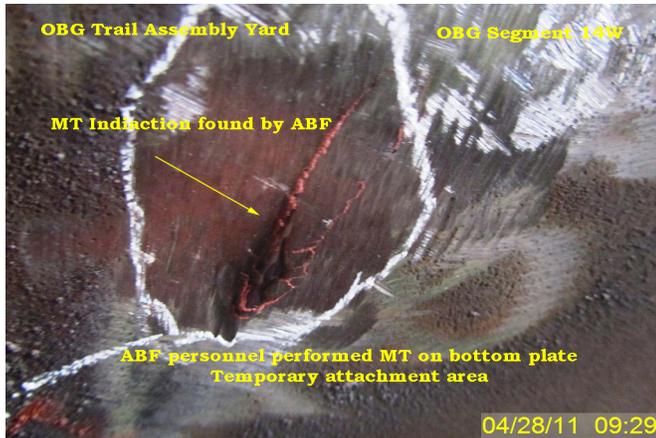
This QA inspector observed ABF personnel performed Magnetic particle Testing (MT) on Bottom plate of OBG Segment 14W. See the attached picture.
