DEPARTMENT OF TRANSPORTATION

Quality Assurance and Source Inspection

Contract #: 04-0120F4Cty: SF/ALA Rte: 80 PM: 13.2/13.9File #: 69.28**WELDING INSPECTION REPORT****Resident Engineer:** Siegenthaler, Peter**Address:** 333 Burma Road**City:** Oakland, CA 94607**Report No:** WIR-023420**Date Inspected:** 01-May-2011**Project Name:** SAS Superstructure**OSM Arrival Time:** 700**Prime Contractor:** American Bridge/Fluor Enterprises, a JV**OSM Departure Time:** 1900**Contractor:** Zhenhua Port Machinery Company, Ltd (ZPMC), Changxing Island **Location:** Shanghai, China**CWI Name:** Zheng zhi qiang**CWI Present:** Yes No**Inspected CWI report:** Yes No N/A**Rod Oven in Use:** Yes No N/A**Electrode to specification:** Yes No N/A**Weld Procedures Followed:** Yes No N/A**Qualified Welders:** Yes No N/A**Verified Joint Fit-up:** Yes No N/A**Approved Drawings:** Yes No N/A**Approved WPS:** Yes No N/A**Delayed / Cancelled:** Yes No N/A**Bridge No:** 34-0006**Component:** OBG Components**Summary of Items Observed:**

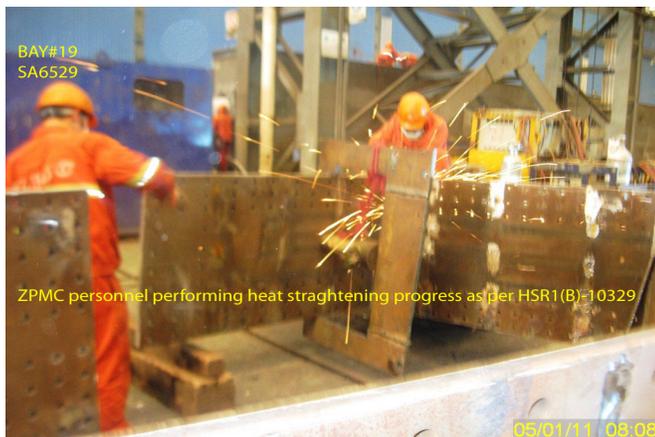
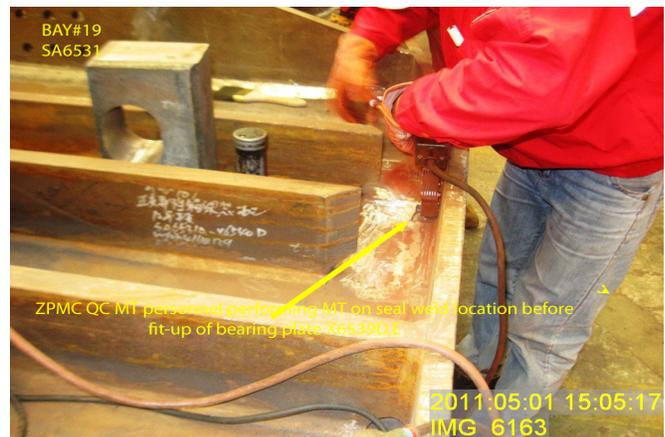
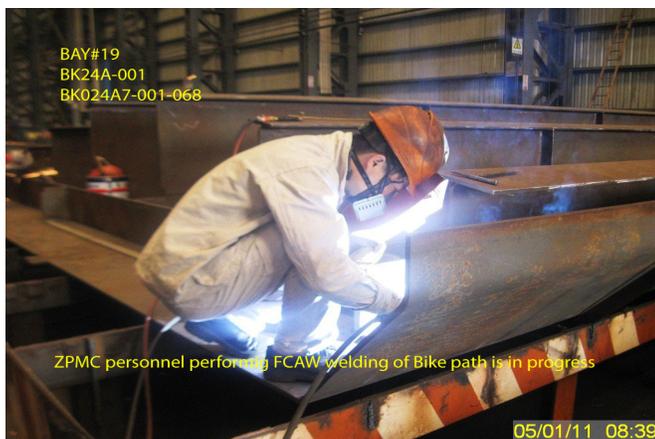
ZPMC personnel performing heat straightening of cable bracket bottom flange is in progress of SA6529 & SA6029 as per HSR1 (B)-10329.

ZPMC QC NDT MT personnel performing MT of fillet welds which is connecting bike path top plate to stringer plate , the bike path is identified as BK25A-001.

ZPMC personnel performing Temporary attachment removal of cable bracket is in progress.

ZPMC personnel performing grinding of cable bracket fillet, CJP and PJP welds are in progress.

ZPMC personnel performed MT on seal plate (SP1) weld location of web plate connecting bottom plate is identified as X6581 before doing fit-up of bearing plate X6539D, E.
