Contract #: 04-0120F4Cty: SF/ALA Rte: 80 PM: 13.2/13.9File #: 99.28**WELDING INSPECTION REPORT****Resident Engineer:** Siegenthaler, Peter**Address:** 333 Burma Road**City:** Oakland, CA 94607**Report No:** WIR-023429**Date Inspected:** 06-May-2011**Project Name:** SAS Superstructure**OSM Arrival Time:** 700**Prime Contractor:** American Bridge/Fluor Enterprises, a JV**OSM Departure Time:** 1900**Contractor:** Zhenhua Port Machinery Company, Ltd (ZPMC), Changxing Island **Location:** Shanghai

WELDING INSPECTION REPORT

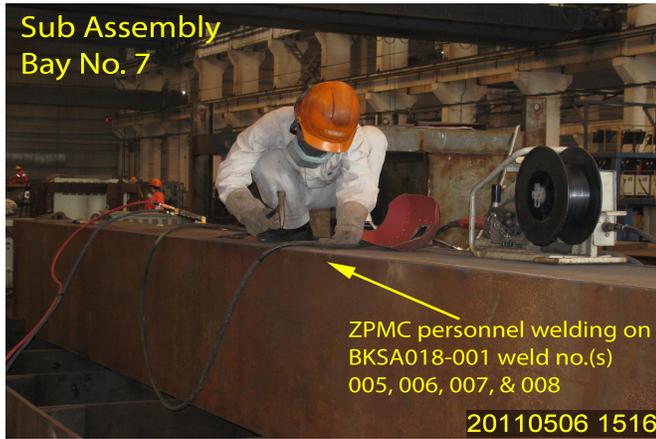
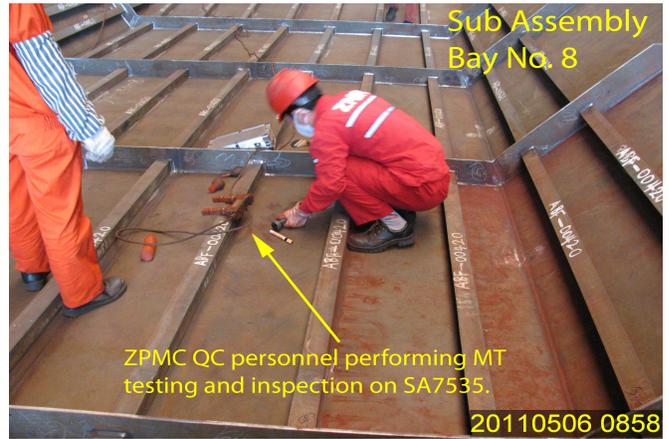
Unless otherwise noted above all items observed on this day appeared to be in general compliance with the applicable contract documents
