DEPARTMENT OF TRANSPORTATION

Contract #: 04-0120F4Cty: SF/ALA Rte: 80 PM: 13.2/13.9File #: 99.28**WELDING INSPECTION REPORT****Resident Engineer:** Siegenthaler, Peter**Address:** 333 Burma Road**City:** Oakland, CA 94607**Report No:** WIR-023430**Date Inspected:** 04-May-2011**Project Name:** SAS Superstructure**OSM Arrival Time:** 700**Prime Contractor:** American Bridge/Fluor Enterprises, a JV**OSM Departure Time:** 1900**Contractor:** Zhenhua Port Machinery Company, Ltd (ZPMC), Changxing Island **Location:** Shanghai

WELDING INSPECTION REPORT

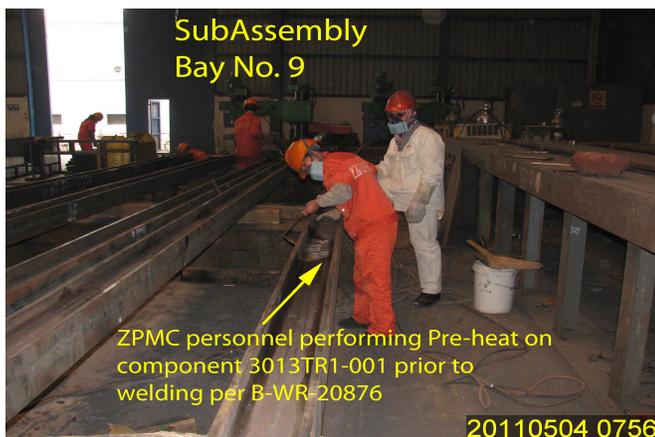
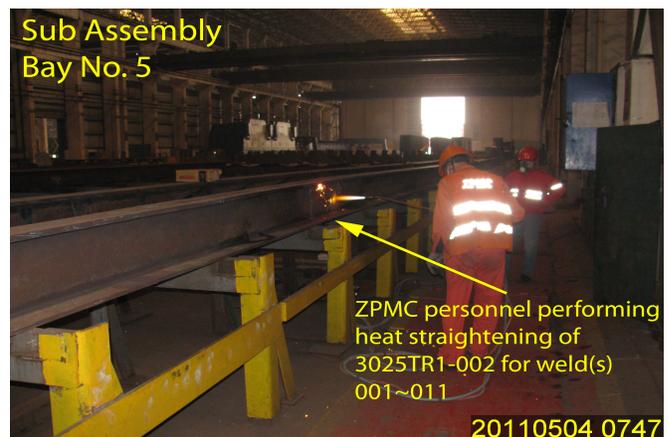
ZPMC personnel heat straightening Orthotropic Box Girder (OBG) traveler rail member identified as 3025TR1-002 for weld(s) 001~011. Distortion appeared to be caused by welding. ZPMC Quality Control (QC) inspector identified as Mr. Tian Lei was present to monitor the heat straightening process. The heat straightening appeared to comply with Heat Straightening Report (HSR) no. HSR(B)-10291.

ZPMC personnel heat straightening Orthotropic Box Girder (OBG) traveler rail member identified as 3026TR1-001 for weld(s) 001~016. Distortion appeared to be caused by welding. ZPMC Quality Control (QC) inspector identified as Mr. Tian Lei was present to monitor the heat straightening process. The heat straightening appeared to comply with Heat Straightening Report (HSR) no. HSR(B)-10291.
