Quality Assurance and Source Inspection

Contract #: 04-0120F4Cty: SF/ALA Rte: 80 PM: 13.2/13.9File #: 99.28**WELDING INSPECTION REPORT****Resident Engineer:** Siegenthaler, Peter**Address:** 333 Burma Road**City:** Oakland, CA 94607**Report No:** WIR-023434**Date Inspected:** 28-Apr-2011**Project Name:** SAS Superstructure**OSM Arrival Time:** 700**Prime Contractor:** American Bridge/Fluor Enterprises, a JV**OSM Departure Time:** 1900**Contractor:** Zhenhua Port Machinery Company, Ltd (ZPMC), Changxing Island **Location:** Shanghai

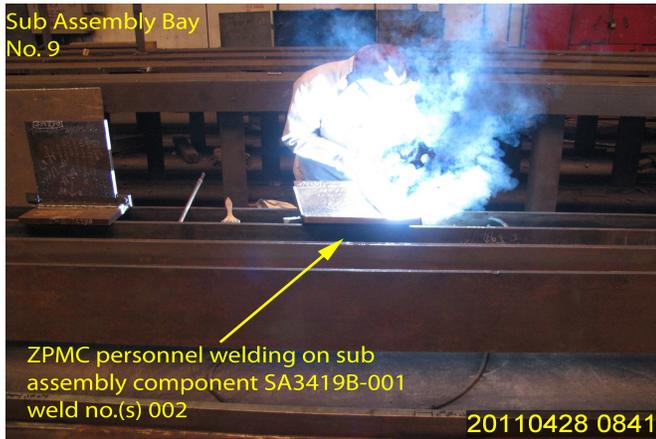
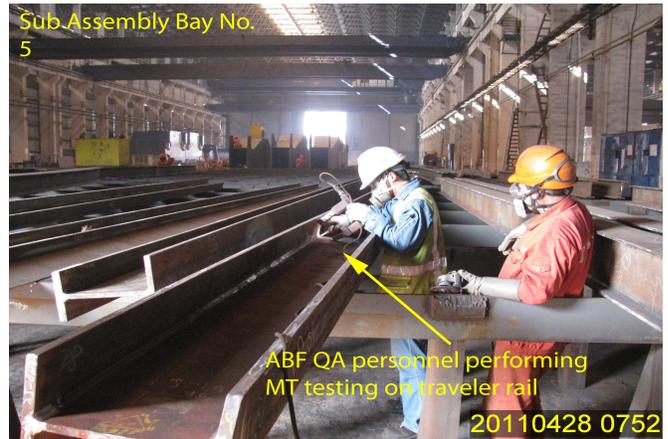
Unless otherwise noted above all items observed on this day appeared to be in general compliance with the applicable contract documents
