Contract #: 04-0120F4Cty: SF/ALA Rte: 80 PM: 13.2/13.9File #: 69.28**WELDING INSPECTION REPORT****Resident Engineer:** Siegenthaler, Peter**Address:** 333 Burma Road**City:** Oakland, CA 94607**Report No:** WIR-023496**Date Inspected:** 11-May-2011**Project Name:** SAS Superstructure**OSM Arrival Time:** 700**Prime Contractor:** American Bridge/Fluor Enterprises, a JV**OSM Departure Time:** 1900**Contractor:** Zhenhua Port Machinery Company, Ltd (ZPMC), Changxing Island **Location:** Shanghai, China

WELDING INSPECTION REPORT

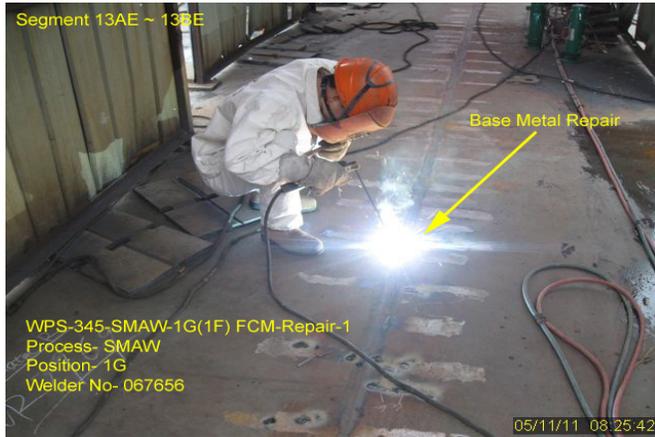
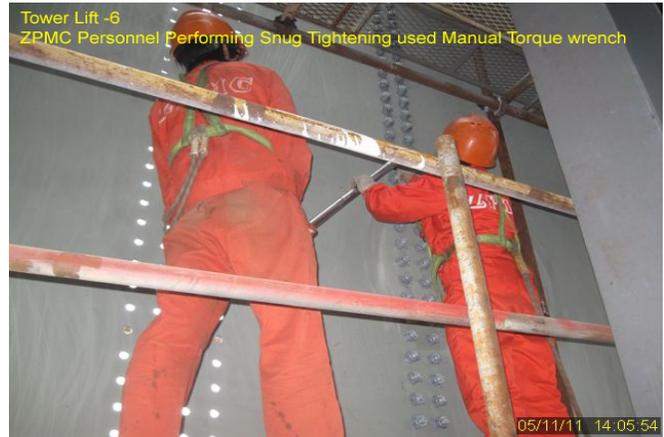
This Quality Assurance (QA) Inspector witnessed final tension verification for Splice Plate East, North, South, and West. Inspected 10% on a random basis and found the tension to be in general compliance. Inspection was performed against the Notification No. 00679 Dated May 11, 2011.

Bolt sizes used were M27 x 75 DHGM270030 and final torque required was 586 N-m.

Manual Torque wrench used was SN. XQ2-666. See attached photo for further details.

This QA Inspector observed ZPMC qualified welding personnel identified as 037779 perform Shielded Metal Arc Welding (SMAW), weld joint identified as SEG3013-001; located On Orthotropic Box Girder (OBG) Deck Plate to Edge Plate CJP Weld; ZPMC Quality Control (QC) is identified as Mr. Shen Jian Bo. This QA Inspector observed the base material appears to have been preheated by an electrical heating element prior to welding. The Welding Repair Report (WRR) was B-WR20812. ZPMC Quality Control (QC) Mr. Shen Jian Bo was onsite monitoring the welding variables. The welding variables recorded by QC appeared to comply with applicable WPS-345-SMAW 4G (4F)

FCM-Repair-1. See attached photo for further details.

This QA Inspector observed ZPMC qualified welding personnel identified as 037779 perform Shielded Metal Arc Welding (SMAW), Base metal repair ; located On Orthotropic Box Girder (OBG) Deck Plate Weld; ZPMC Quality Control (QC) is identified as Mr. Shen Jian Bo. This QA Inspector observed the base material appears to have been preheated by an electrical heating element prior to welding. The Critical Welding Repair Report (CWRR) was B-CWR2969. ZPMC Quality Control (QC) Mr. Shen Jian Bo was onsite monitoring the welding variables. The welding variables recorded by QC appeared to comply with applicable WPS-345-SMAW 1G (1F) FCM-Repair-1. See attached photo for further details.
