DEPARTMENT OF TRANSPORTATION

Contract #: 04-0120F4Cty: SF/ALA Rte: 80 PM: 13.2/13.9File #: 69.28**WELDING INSPECTION REPORT****Resident Engineer:** Siegenthaler, Peter**Address:** 333 Burma Road**City:** Oakland, CA 94607**Report No:** WIR-023587**Date Inspected:** 10-May-2011**Project Name:** SAS Superstructure**OSM Arrival Time:** 1900**Prime Contractor:** American Bridge/Fluor Enterprises, a JV**OSM Departure Time:** 700**Contractor:** Zhenhua Port Machinery Company, Ltd (ZPMC), Changxing Island **Location:** Shanghai, China**CWI Name:** See Below**CWI Present:** Yes No**Inspected CWI report:** Yes No N/A**Rod Oven in Use:** Yes No N/A**Electrode to specification:** Yes No N/A**Weld Procedures Followed:** Yes No N/A**Qualified Welders:** Yes No N/A**Verified Joint Fit-up:** Yes No N/A**Approved Drawings:** Yes No N/A**Approved WPS:** Yes No N/A**Delayed / Cancelled:** Yes No N/A**Bridge No:** 34-0006**Component:** OBG**Summary of Items Observed:**

OBG Trial Assembly

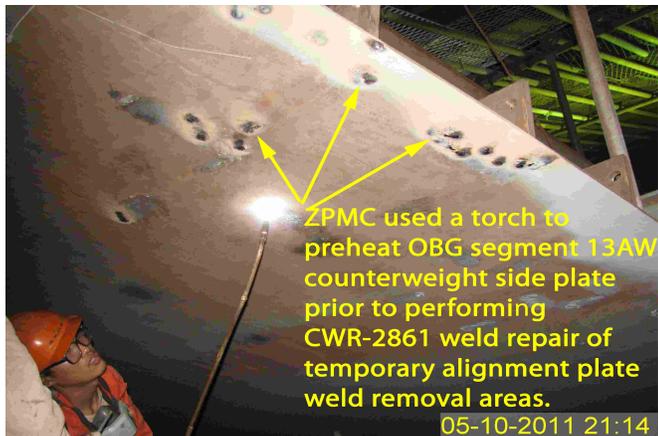
This QA Inspector observed ZPMC welder Mr. Xu Zichuan, stencil 205098 used shielded metal arc welding procedure WPS-345-SMAW-4F(4G)-FCM-Repair-1 to make base metal weld repairs of OBG segment 13AW counterweight side plate. ZPMC QC informed this QA Inspector that weld repair document B-CWR-2861 documents repairs of this weld. This QA Inspector measured a welding current of approximately 170 amps and the base materials appear to have been preheated with an electric heater and Mr. Xu Zichuan appeared to be certified to make this weld. Items observed on this date appeared to generally comply with applicable contract documents. See the photograph below for additional information.

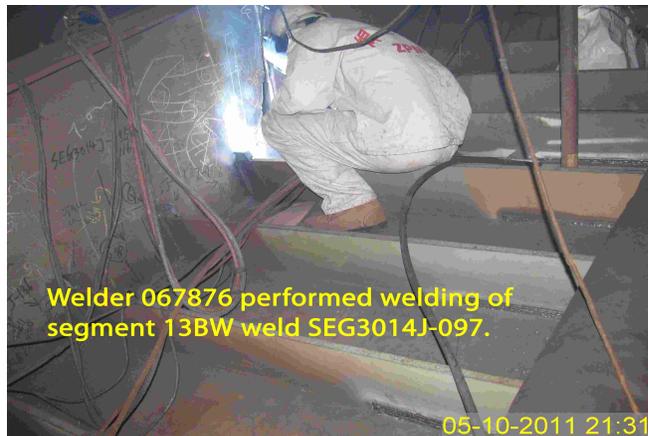
This QA Inspector observed ZPMC welder Mr. Jiang Junlin, stencil 067876 used flux cored welding procedure WPS-345-FCAW-3G(3F)-ESAB-Repair-FCM to make repairs to weld SEG3014J-097. ZPMC QC informed this QA Inspector that weld repair document B-WR-20824 documents repairs of this weld. This QA Inspector observed a welding current of approximately 250 amps, 26.0 volts, the base material had been preheated with a torch and Mr. Jiang Junlin appeared to be certified to make this weld. Items observed on this date appeared to generally comply with applicable contract documents. See the photograph below for additional information.
