Contract #: 04-0120F4Cty: SF/ALA Rte: 80 PM: 13.2/13.9File #: 69.28**WELDING INSPECTION REPORT****Resident Engineer:** Siegenthaler, Peter**Address:** 333 Burma Road**City:** Oakland, CA 94607**Report No:** WIR-023682**Date Inspected:** 15-May-2011**Project Name:** SAS Superstructure**OSM Arrival Time:** 1500**Prime Contractor:** American Bridge/Fluor Enterprises, a JV**OSM Departure Time:** 300**Contractor:** Zhenhua Port Machinery Company, Ltd (ZPMC), Changxing Island **Location:** Shanghai, China

**Bridge No:** 34-0006**Component:** OBG Segment Assembly**Summary of Items Observed:**

Trial Assembly / OBG Segment 13BE

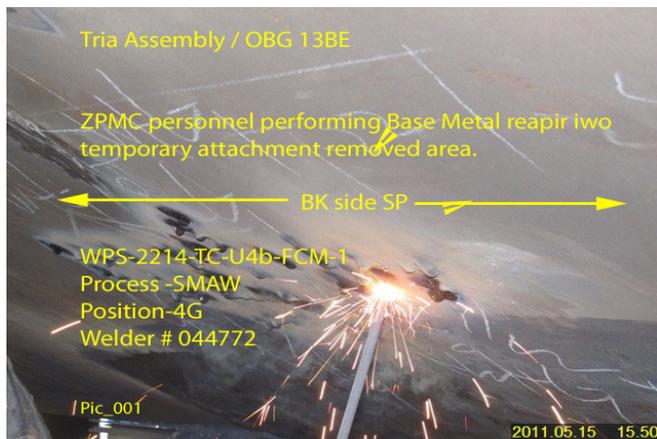
Shielded Metal Arc Welding (SMAW) in the 4G position of BK side temporary attachment removed area, as per B-CWR # 2880. The welder is identified as 044772. ZPMC Quality Control (QC) is identified as Lv Li Qing. The welding variables recorded by QC appeared to comply with WPS-345-SMAW-4G(42F)-FCM-Repair. See attached photograph Pic\_001.
