Contract #: 04-0120F4Cty: SF/ALA Rte: 80 PM: 13.2/13.9File #: 69.28**WELDING INSPECTION REPORT****Resident Engineer:**Siegenthaler, Peter**Address:** 333 Burma Road**City:** Oakland, CA 94607**Report No:** WIR-023698**Date Inspected:** 13-May-2011**Project Name:** SAS Superstructure**OSM Arrival Time:** 700**Prime Contractor:** American Bridge/Fluor Enterprises, a JV**OSM Departure Time:** 1900**Contractor:** Zhenhua Port Machinery Company, Ltd (ZPMC), Changxing Island **Location:** Shanghai,China**CWI Name:** Liu Hua Jie/Lv Li Qing**CWI Present:** Yes No**Inspected CWI report:** Yes No N/A**Rod Oven in Use:** Yes No N/A**Electrode to specification:** Yes No N/A**Weld Procedures Followed:** Yes No N/A**Qualified Welders:** Yes No N/A**Verified Joint Fit-up:** Yes No N/A**Approved Drawings:** Yes No N/A**Approved WPS:** Yes No N/A**Delayed / Cancelled:** Yes No N/A**Bridge No:** 34-0006**Component:** OBG**Summary of Items Observed:**

OBG Trial Assembly

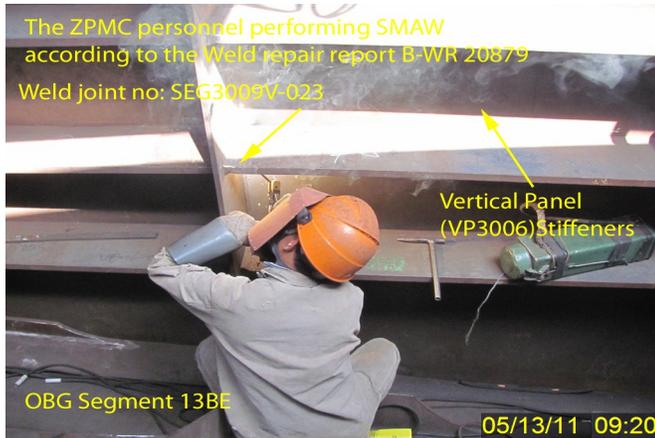
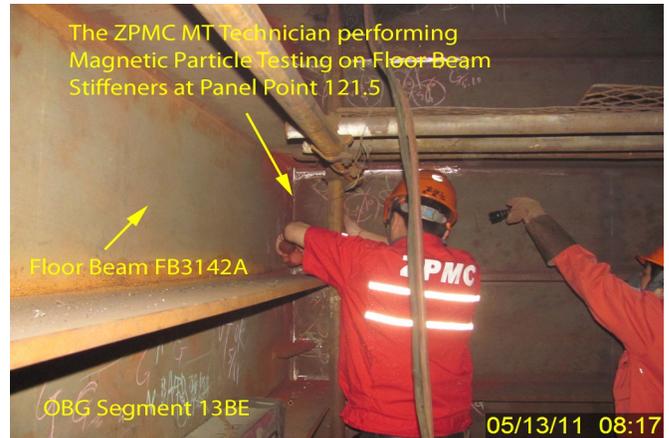
SMAW welding of weld joint No: SEG3009V-023 located on OBG Segment 13BE Vertical Panel stiffener. Welder is identified as #051359. ZPMC CWI is identified as Mr. Lv Li Qing. Welding was performed with the weld repair report BWR-20879. The welding variables recorded by QC appeared to comply with the WPS-345-SMAW-4G(4F)-FCM-Repair-1. Please see the attached picture.
