**DEPARTMENT OF TRANSPORTATION**

Contract #: 04-0120F4Cty: SF/ALA Rte: 80 PM: 13.2/13.9File #: 69.28**WELDING INSPECTION REPORT****Resident Engineer:** Siegenthaler, Peter**Address:** 333 Burma Road**City:** Oakland, CA 94607**Report No:** WIR-023734**Date Inspected:** 13-May-2011**Project Name:** SAS Superstructure**OSM Arrival Time:** 1900**Prime Contractor:** American Bridge/Fluor Enterprises, a JV**OSM Departure Time:** 700**Contractor:** Zhenhua Port Machinery Company, Ltd (ZPMC), Changxing Island **Location:** Shanghai, China**CWI Name:** See Below**CWI Present:** Yes No**Inspected CWI report:** Yes No N/A**Rod Oven in Use:** Yes No N/A**Electrode to specification:** Yes No N/A**Weld Procedures Followed:** Yes No N/A**Qualified Welders:** Yes No N/A**Verified Joint Fit-up:** Yes No N/A**Approved Drawings:** Yes No N/A**Approved WPS:** Yes No N/A**Delayed / Cancelled:** Yes No N/A**Bridge No:** 34-0006**Component:** OBG**Summary of Items Observed:**

**OBG Trial Assembly**

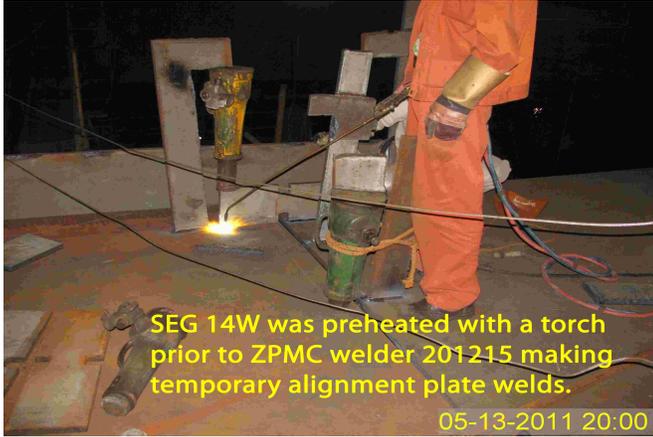
This QA Inspector observed ZPMC welder Mr. Li Jian stencil 067829 used shielded metal arc welding procedure specification WPS-B-P-2214-B-U2A-FCM-1 to make weld OBG13-001. This weld joins the deck plates between OBG segments 13AW and 13BW. This QA Inspector observed a welding current of approximately 160 amps, the base material had been preheated with electric heaters and Mr. Li Jian appeared to be certified to make this weld. Items observed on this date appeared to generally comply with applicable contract documents.
