DEPARTMENT OF TRANSPORTATION

Quality Assurance and Source Inspection

Contract #: 04-0120F4Cty: SF/ALA Rte: 80 PM: 13.2/13.9File #: 1.28**WELDING INSPECTION REPORT****Resident Engineer:** Siegenthaler, Peter**Address:** 333 Burma Road**City:** Oakland, CA 94607**Report No:** WIR-023743**Date Inspected:** 18-May-2011**Project Name:** SAS Superstructure**OSM Arrival Time:** 700**Prime Contractor:** American Bridge/Fluor Enterprises, a JV**OSM Departure Time:** 1730**Contractor:** American Bridge/Fluor Enterprises, a JV**Location:** Job Site**CWI Name:** See Report Below**CWI Present:** Yes No**Inspected CWI report:** Yes No N/A**Rod Oven in Use:** Yes No N/A**Electrode to specification:** Yes No N/A**Weld Procedures Followed:** Yes No N/A**Qualified Welders:** Yes No N/A**Verified Joint Fit-up:** Yes No N/A**Approved Drawings:** Yes No N/A**Approved WPS:** Yes No N/A**Delayed / Cancelled:** Yes No N/A**Bridge No:** 34-0006**Component:** Orthotropic Box Girders & Tower**Summary of Items Observed:**

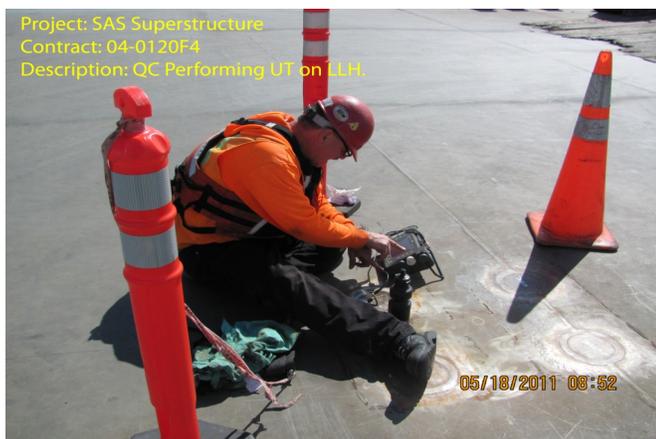
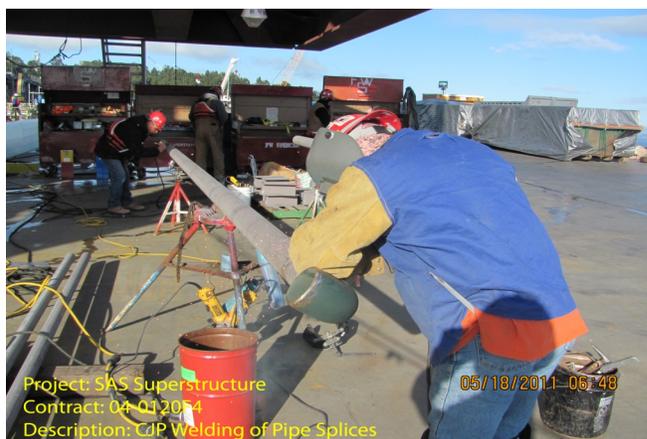
The QAI observed the fit-up and CJP welding of the pipe 4" compressed air system splices identified as 5-CA4-TD42-SW and 6-CA4-TD42-SW. The fit-up and welding was performed by FW Spencer personnel Hector Garcia and Rick Kiikvee utilizing the WPS identified as 1-12-1.

The QAI observed the CJP welding of the lifting lug holes identified as WN:8E-PP68-E4-W1 and WN:8E-PP68-E3-W4. The welding was performed by Jason Collins- ID-8128 utilizing the WPS's identified as ABF-WPS-D15-1050A-CU, Rev.0. The QAI also observed the QC inspector perform the visual inspection and verify the welding parameters during the production welding. The welding and the inspection performed by Fred

The digital photographs below illustrate some of the related work observed during this shift.
