Contract #: 04-0120F4Cty: SF/ALA Rte: 80 PM: 13.2/13.9File #: 69.28**WELDING INSPECTION REPORT****Resident Engineer:** Siegenthaler, Peter**Address:** 333 Burma Road**City:** Oakland, CA 94607**Report No:** WIR-023765**Date Inspected:** 19-May-2011**Project Name:** SAS Superstructure**OSM Arrival Time:** 700**Prime Contractor:** American Bridge/Fluor Enterprises, a JV**OSM Departure Time:** 1900**Contractor:** Zhenhua Port Machinery Company, Ltd (ZPMC), Changxing Island **Location:** Shanghai, China**CWI Name:** Li yan hua**CWI Present:** Yes No**Inspected CWI report:** Yes No N/A**Rod Oven in Use:** Yes No N/A**Electrode to specification:** Yes No N/A**Weld Procedures Followed:** Yes No N/A**Qualified Welders:** Yes No N/A**Verified Joint Fit-up:** Yes No N/A**Approved Drawings:** Yes No N/A**Approved WPS:** Yes No N/A**Delayed / Cancelled:** Yes No N/A**Bridge No:** 34-0006**Component:** OBG Components**Summary of Items Observed:**

# WELDING INSPECTION REPORT

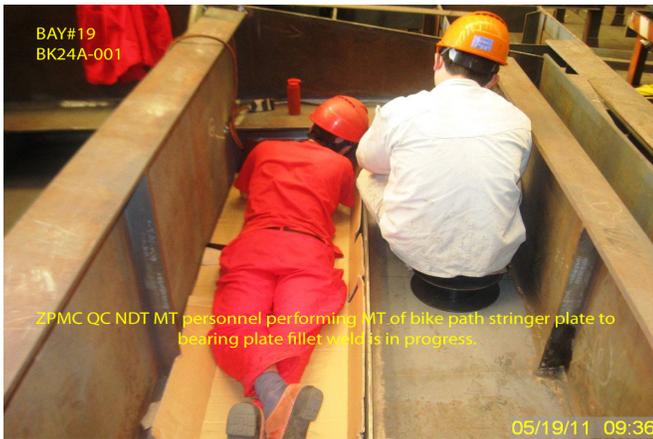
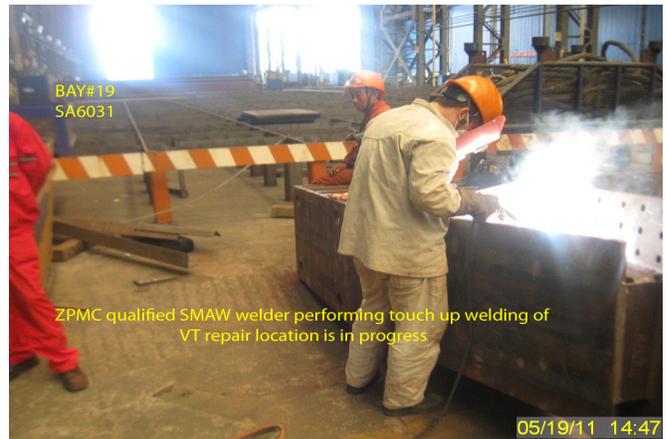
This QA inspector performed MT 15% of weld areas previously tested and accepted by ZPMC Quality Control personnel. This QA inspector generated an MT report for this date. The members are identified as OBG Cable bracket. The weld designations reviewed as follows

Unless otherwise noted, all work observed on this date appeared to generally comply with applicable contract documents.
