**DEPARTMENT OF TRANSPORTATION**

Contract #: 04-0120F4Cty: SF/ALA Rte: 80 PM: 13.2/13.9File #: 69.28**WELDING INSPECTION REPORT****Resident Engineer:** Siegenthaler, Peter**Address:** 333 Burma Road**City:** Oakland, CA 94607**Report No:** WIR-023850**Date Inspected:** 19-May-2011**Project Name:** SAS Superstructure**OSM Arrival Time:** 700**Prime Contractor:** American Bridge/Fluor Enterprises, a JV**OSM Departure Time:** 1900**Contractor:** Zhenhua Port Machinery Corporation, Ltd (ZPMC), Changxing Island **Location:** Shanghai, China**CWI Name:** Mr. Mai Quin Li**CWI Present:** Yes No**Inspected CWI report:** Yes No N/A**Rod Oven in Use:** Yes No N/A**Electrode to specification:** Yes No N/A**Weld Procedures Followed:** Yes No N/A**Qualified Welders:** Yes No N/A**Verified Joint Fit-up:** Yes No N/A**Approved Drawings:** Yes No N/A**Approved WPS:** Yes No N/A**Delayed / Cancelled:** Yes No N/A**Bridge No:** 34-0006**Component:** Traveler Rails & Handrail**Summary of Items Observed:**

## WELDING INSPECTION REPORT

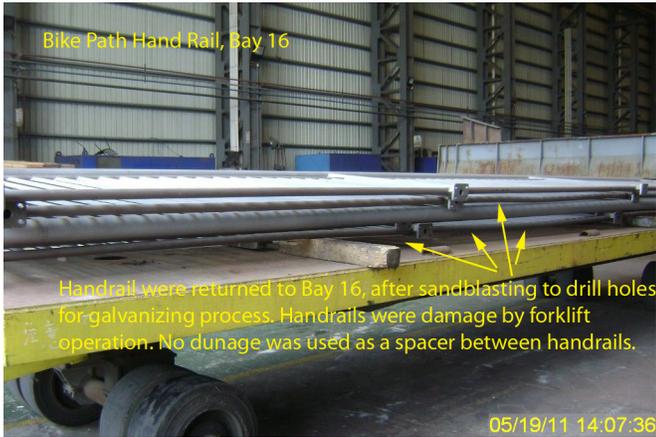
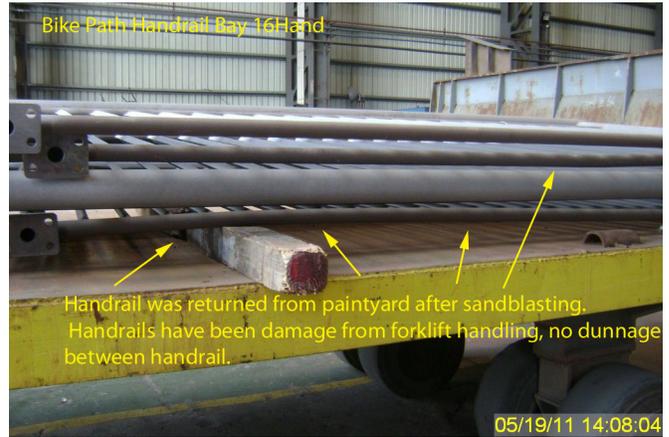
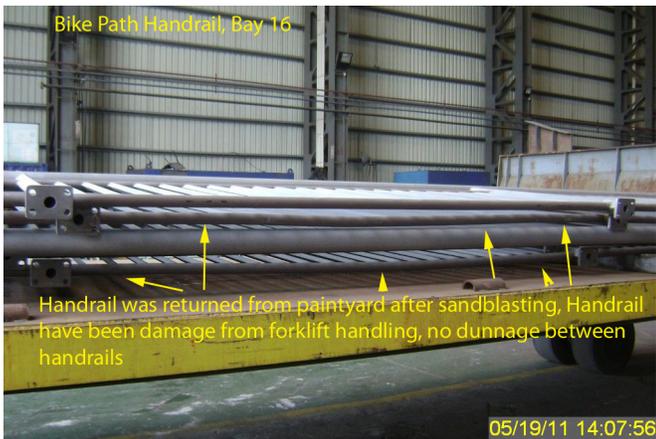
This QA observed the following components in the paint yard, OBG, Bike Path Hand Rails being lifted from the ground and stack one on top of the without any care to the components no dunnage in between each railing causing damage (buckling, notches, knocking out of straightness, bending pipe rail) to handrail. Hand rail were being taken back to Bay 16 to have breather holes drilled in them for galvanizing process. This QA took pictures of the incident in paint yard and of the trailer loaded with handrail after it was delivered to Bay 16.
