**DEPARTMENT OF TRANSPORTATION**

Contract #: 04-0120F4Cty: SF/Ala Rte: 80 PM: 13.2/13.9File #: 69.28**WELDING INSPECTION REPORT****Resident Engineer:** Siegenthaler, Peter**Address:** 333 Burma Road**City:** Oakland, CA 94607**Report No:** WIR-024119**Date Inspected:** 19-May-2011**Project Name:** SAS Superstructure**OSM Arrival Time:** 1900**Prime Contractor:** American Bridge/Fluor Enterprises, a JV**OSM Departure Time:** 700**Contractor:** Zhenhua Port Machinery Company, Ltd (ZPMC), Changxing Island **Location:** Shanghai, China**CWI Name:** See below**CWI Present:** Yes No**Inspected CWI report:** Yes No N/A**Rod Oven in Use:** Yes No N/A**Electrode to specification:** Yes No N/A**Weld Procedures Followed:** Yes No N/A**Qualified Welders:** Yes No N/A**Verified Joint Fit-up:** Yes No N/A**Approved Drawings:** Yes No N/A**Approved WPS:** Yes No N/A**Delayed / Cancelled:** Yes No N/A**Bridge No:** 34-0006**Component:** OBG Components**Summary of Items Observed:**

## WELDING INSPECTION REPORT

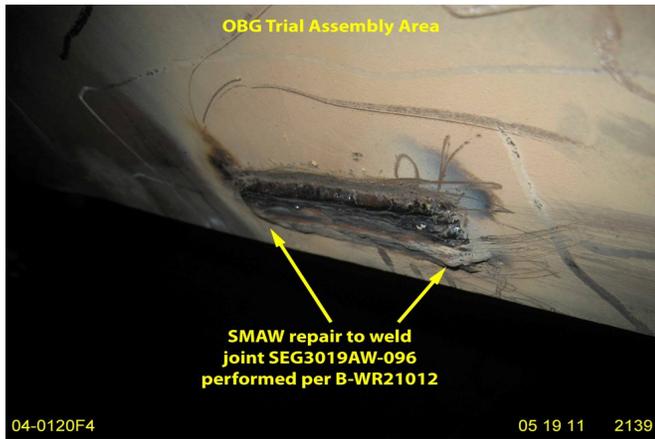
SMAW repair welding of weld joint SEG3019AW-096 located on PCMK OBG 14E. Welder was identified as 044779. QC was identified as ZPMC CWI Liu Yang (QC1). Assisting QC1 at this location and appearing to be monitoring the welding operation and recording data was ZPMC QC Xie Ming Feng (QCA1), who was not a CWI.

Weld variables recorded by QCA1 appeared to comply with WPS-345-SMAW-2G(2F)-FCM-repair-1 as displayed on ZPMC Weld Repair Report B-WR21012 as presented to this QA Inspector and verbally identified by QCA1. See photo below of repair welding apparently completed.
