**DEPARTMENT OF TRANSPORTATION**

Contract #: 04-0120F4Cty: SF/ALA Rte: 80 PM: 13.2/13.9File #: 69.28**WELDING INSPECTION REPORT****Resident Engineer:** Siegenthaler, Peter**Address:** 333 Burma Road**City:** Oakland, CA 94607**Report No:** WIR-024145**Date Inspected:** 02-Jun-2011**Project Name:** SAS Superstructure**OSM Arrival Time:** 700**Prime Contractor:** American Bridge/Fluor Enterprises, a JV**OSM Departure Time:** 1900**Contractor:** Zhenhua Port Machinery Company, Ltd (ZPMC), Changxing Island **Location:** Shanghai, China

Orthotropic Box Girder (OBG) at Trial Assembly Areas

BAY 11 – (Skid More Test)

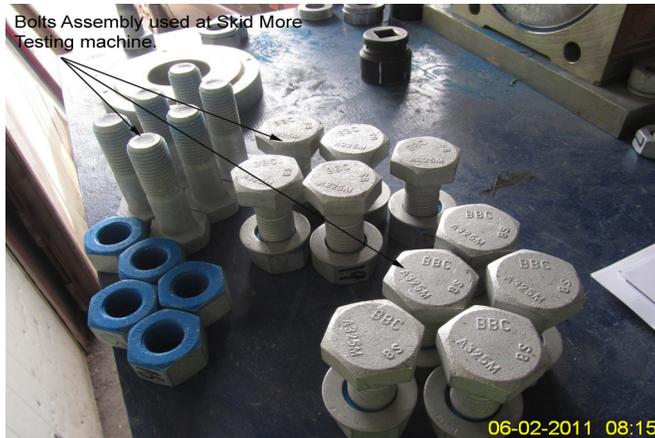
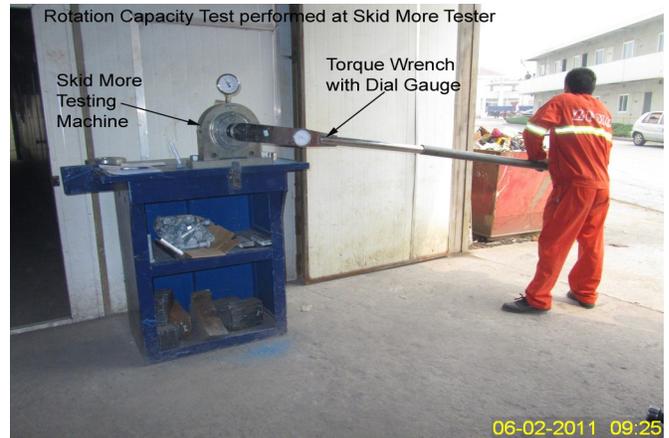
This QA Inspector witnessed Bolt Testing for ASTM A325 Grade. Observed ZPMC QC Mr. Zhang Hai Jung performing bolts testing and ZPMC QC Inspector Mr. Fan Xiao Hun generating report against the testing.

The testing of bolts was performed to determining Nut Rotation from Snug-Tight condition for Turn-of-Nut Pre-tensioning and High Tension bolt capability verification test.

Bolt assembly identified as ASTM A325 (High Strength Bolt), Bolt Assembly comprises of (a Bolt, a Nut and a Washer).

Bolt testing was performed on a Unit: Skidmore-Wilhelm; Model: HT; Serial Number: 1014 (Calibration Expiration due date on August 23, 2011) and Torque Wrench identified as XO-486 and Torque Wrench with Dial gauge on it is identified as XO-2 (Calibration Expiration due date on October 03, 2011).
