DEPARTMENT OF TRANSPORTATION

Quality Assurance and Source Inspection

Contract #: 04-0120F4Cty: SF/ALA Rte: 80 PM: 13.2/13.9File #: 99.28**WELDING INSPECTION REPORT****Resident Engineer:** Siegenthaler, Peter**Address:** 333 Burma Road**City:** Oakland, CA 94607**Report No:** WIR-024162**Date Inspected:** 21-May-2011**Project Name:** SAS Superstructure**OSM Arrival Time:** 700**Prime Contractor:** American Bridge/Fluor Enterprises, a JV**OSM Departure Time:** 1900**Contractor:** Zhenhua Port Machinery Company, Ltd (ZPMC) Chanxing Island**Location:** Shanghai, China**CWI Name:** Mr. Shi Lei**CWI Present:** Yes No**Inspected CWI report:** Yes No N/A**Rod Oven in Use:** Yes No N/A**Electrode to specification:** Yes No N/A**Weld Procedures Followed:** Yes No N/A**Qualified Welders:** Yes No N/A**Verified Joint Fit-up:** Yes No N/A**Approved Drawings:** Yes No N/A**Approved WPS:** Yes No N/A**Delayed / Cancelled:** Yes No N/A**Bridge No:** 34-0006**Component:** OBG Segment**Summary of Items Observed:**

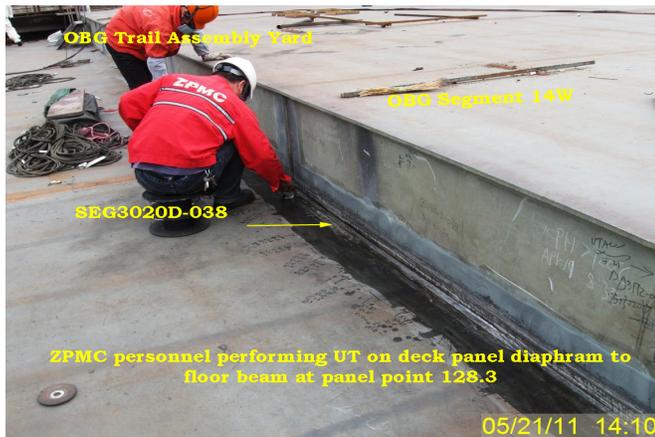
This QA inspector observed ZPMC personnel performed Ultrasonic Testing (UT) on deck panel diaphragm to floor beam of OBG Segment 14W. The weld number is identified as SEG3020D-038. See the attached pictures.
