Contract #: 04-0120F4Cty: SF/ALA Rte: 80 PM: 13.2/13.9File #: 69.28**WELDING INSPECTION REPORT****Resident Engineer:** Siegenthaler, Peter**Address:** 333 Burma Road**City:** Oakland, CA 94607**Report No:** WIR-024275**Date Inspected:** 01-Jun-2011**Project Name:** SAS Superstructure**OSM Arrival Time:** 700**Prime Contractor:** American Bridge/Fluor Enterprises, a JV**OSM Departure Time:** 1900**Contractor:** Zhenhua Port Machinery Company, Ltd (ZPMC), Changxing Island **Location:** Shanghai, China

Orthotropic Box Girder (OBG) at Trial Assembly Areas

BAY 11 – (Skid More Test)

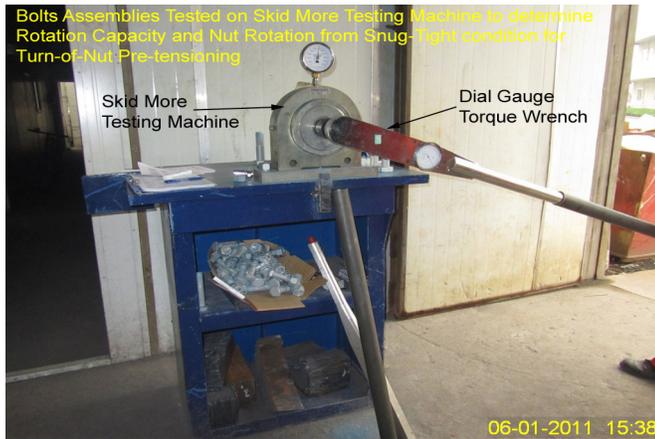
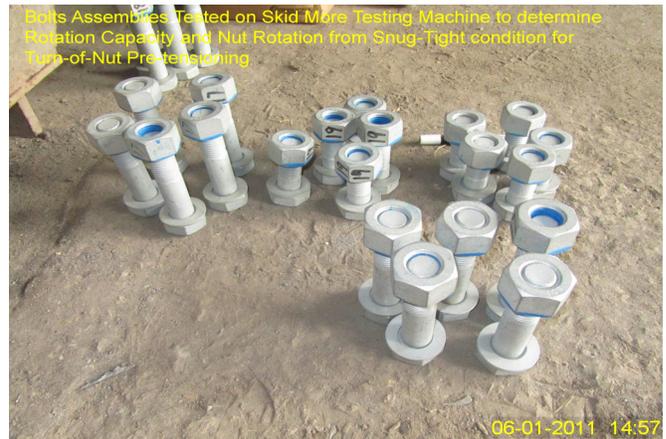
This QA Inspector witnessed Bolt Testing for ASTM A325 Grade. Observed ZPMC QC Mr. Zhang Hai Jung performing bolts testing and ZPMC QC Inspector Mr. Fan Xiao Hun generating report against the testing.

The testing of bolts was performed to determining Nut Rotation from Snug-Tight condition for Turn-of-Nut Pre-tensioning and High Tension bolt capability verification test.

Bolt testing was performed on a Unit: Skidmore-Wilhelm; Model: HT; Serial Number: 1014 (Calibration Expiration due date on August 23, 2011) and Torque Wrench identified as XO-486 and Torque Wrench with Dial gauge on it is identified as XO-2 (Calibration Expiration due date on October 03, 2011).
