**DEPARTMENT OF TRANSPORTATION**

Quality Assurance and Source Inspection

Contract #: 04-0120F4Cty: SF/ALA Rte: 80 PM: 13.2/13.9File #: 69.28**WELDING INSPECTION REPORT****Resident Engineer:** Siegenthaler, Peter**Address:** 333 Burma Road**City:** Oakland, CA 94607**Report No:** WIR-024473**Date Inspected:** 07-Jun-2011**Project Name:** SAS Superstructure**OSM Arrival Time:** 700**Prime Contractor:** American Bridge/Fluor Enterprises, a JV**OSM Departure Time:** 1900**Contractor:** Zhenhua Port Machinery Company, Ltd (ZPMC), Changxing Island **Location:** Shanghai, China**CWI Name:** Mr. Lu Hua Jie**CWI Present:** Yes No**Inspected CWI report:** Yes No N/A**Rod Oven in Use:** Yes No N/A**Electrode to specification:** Yes No N/A**Weld Procedures Followed:** Yes No N/A**Qualified Welders:** Yes No N/A**Verified Joint Fit-up:** Yes No N/A**Approved Drawings:** Yes No N/A**Approved WPS:** Yes No N/A**Delayed / Cancelled:** Yes No N/A**Bridge No:** 34-0006**Component:** Orthotropic Box Girder (OBG)**Summary of Items Observed:**

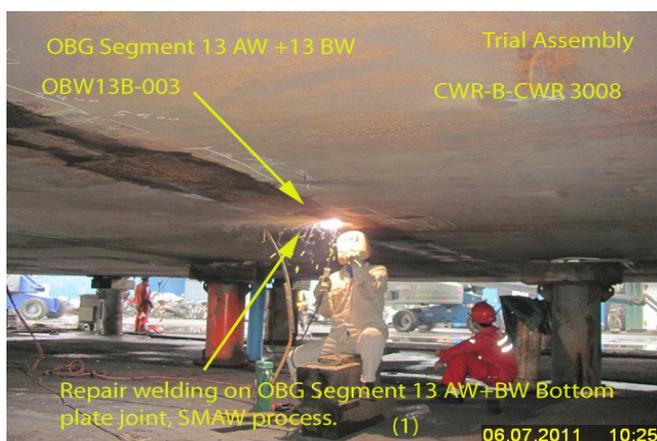
This QA Inspector observed ZPMC qualified welding personnel identified as 045246 Perform Shielded Metal Arc Welding (SMAW) on OBG Segment 13 AW+13BW. Joint identified as OBW13B-003, 001. ZPMC QC Identified as Zhu Lin with Critical welding repair report CWR-B-CWR3008. The welding parameters as measured using QC's calibrated instrument appeared to be in general compliance with WPS-345-SMAW-4G (4F) FCM-Repair-1. For more information see below attached picture number 1.
