Contract #: 04-0120F4Cty: SF/Ala Rte: 80 PM: 13.2/13.9File #: 69.28**WELDING INSPECTION REPORT****Resident Engineer:** Siegenthaler, Peter**Address:** 333 Burma Road**City:** Oakland, CA 94607**Report No:** WIR-024586**Date Inspected:** 30-May-2011**Project Name:** SAS Superstructure**OSM Arrival Time:** 1900**Prime Contractor:** American Bridge/Fluor Enterprises, a JV**OSM Departure Time:** 700**Contractor:** Zhenhua Port Machinery Company, Ltd (ZPMC), Changxing Island **Location:** Shanghai, China**CWI Name:** See below**CWI Present:** Yes No**Inspected CWI report:** Yes No N/A**Rod Oven in Use:** Yes No N/A**Electrode to specification:** Yes No N/A**Weld Procedures Followed:** Yes No N/A**Qualified Welders:** Yes No N/A**Verified Joint Fit-up:** Yes No N/A**Approved Drawings:** Yes No N/A**Approved WPS:** Yes No N/A**Delayed / Cancelled:** Yes No N/A**Bridge No:** 34-0006**Component:** OBG Components**Summary of Items Observed:**

**OBG Trial Assembly Area**

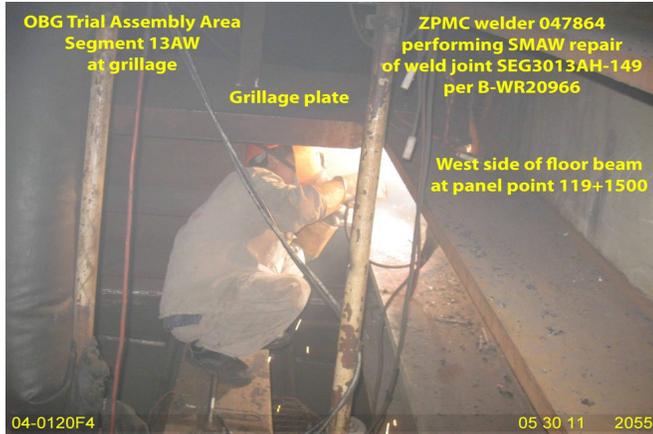
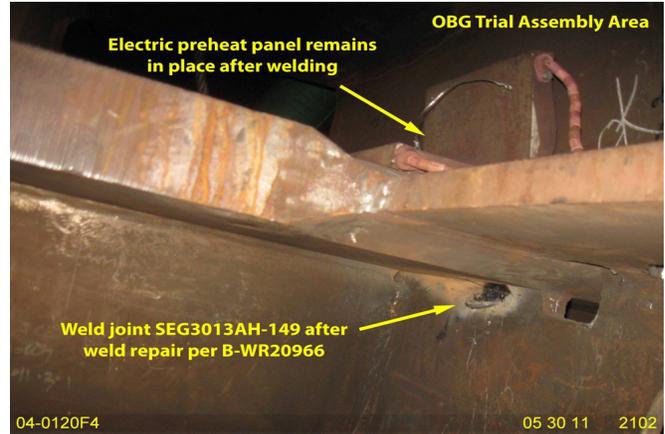
This QA Inspector also randomly observed the following work in progress in the OBG Trial Assembly Area:

SMAW repair welding of various bottom plate I-rib to bottom plate holdback weld joints located at PCMK OBG 13AW/13BW transverse joint. Welder was identified as 066398. QC was identified as ZPMC CWI Li Peng Fei (QC1). Assisting QC1 at this location and appearing to be monitoring the welding operation and recording data was ZPMC QC Zhang Lin (QCA1), who was not a CWI. Weld variables recorded by QCA1 appeared to comply with WPS-345-SMAW-2G(2F)-FCM-repair-1 as verbally identified by QCA1.

SMAW repair welding of weld joint SEG3013AH-149 located on PCMK OBG 13AW. Welder was identified as 047864. QC was identified as QC1. Assisting QC1 at this location and appearing to be monitoring the welding operation and recording data was QCA1, who was not a CWI. Weld variables recorded by QCA1 appeared to comply with WPS-345-SMAW-4G(4F)-FCM-repair-1 as displayed on ZPMC Weld Repair Report B-WR20966 as presented to this QA Inspector and verbally identified by QCA1.
