Contract #: 04-0120F4Cty: SF/ALA Rte: 80 PM: 13.2/13.9File #: 99.28**WELDING INSPECTION REPORT****Resident Engineer:** Siegenthaler, Peter**Address:** 333 Burma Road**City:** Oakland, CA 94607**Report No:** WIR-024628**Date Inspected:** 29-Jan-2011**Project Name:** SAS Superstructure**OSM Arrival Time:** 1500**Prime Contractor:** American Bridge/Fluor Enterprises, a JV**OSM Departure Time:** 300**Contractor:** Zhenhua Port Machinery Company, Ltd (ZPMC) Changxing Island **Location:** Shanghai, China**CWI Name:** Qiu Wei**CWI Present:** Yes No**Inspected CWI report:** Yes No N/A**Rod Oven in Use:** Yes No N/A**Electrode to specification:** Yes No N/A**Weld Procedures Followed:** Yes No N/A**Qualified Welders:** Yes No N/A**Verified Joint Fit-up:** Yes No N/A**Approved Drawings:** Yes No N/A**Approved WPS:** Yes No N/A**Delayed / Cancelled:** Yes No N/A**Bridge No:** 34-0006**Component:** OBG**Summary of Items Observed:**

WELDING

OBG Bay 14

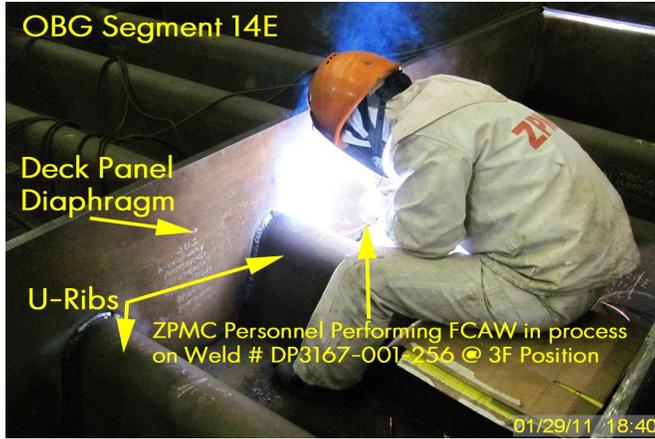
This QA Inspector observed the welding operation per the FCAW process on a weld joint identified as DP3167-001-256/257 located on Deck Plate U-Rib of the OBG Segment 14E. The welder is identified as 206623. ZPMC Quality Control (QC) is identified as Mr. Zhong Yang Gang. The welding variables recorded by QC appeared to comply with WPS-B-T-2133-ESAB. See Photo below
