**DEPARTMENT OF TRANSPORTATION**

Contract #: 04-0120F4Cty: SF/ALA Rte: 80 PM: 13.2/13.9File #: 99.28**WELDING INSPECTION REPORT****Resident Engineer:** Siegenthaler, Peter**Address:** 333 Burma Road**City:** Oakland, CA 94607**Report No:** WIR-024629**Date Inspected:** 31-Jan-2011**Project Name:** SAS Superstructure**OSM Arrival Time:** 1500**Prime Contractor:** American Bridge/Fluor Enterprises, a JV**OSM Departure Time:** 300**Contractor:** Zhenhua Port Machinery Company, Ltd (ZPMC) Changxing Island **Location:** Shanghai, China**CWI Name:** Qiu Wei**CWI Present:** Yes No**Inspected CWI report:** Yes No N/A**Rod Oven in Use:** Yes No N/A**Electrode to specification:** Yes No N/A**Weld Procedures Followed:** Yes No N/A**Qualified Welders:** Yes No N/A**Verified Joint Fit-up:** Yes No N/A**Approved Drawings:** Yes No N/A**Approved WPS:** Yes No N/A**Delayed / Cancelled:** Yes No N/A**Bridge No:** 34-0006**Component:** OBG**Summary of Items Observed:**

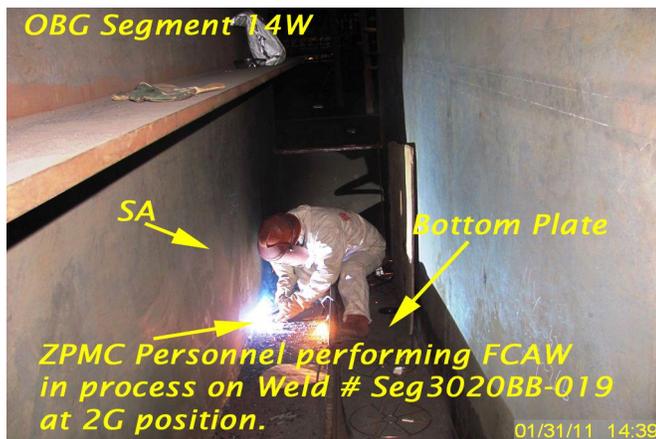
FCAW in the 2G position for the OBG Segment 14W, UT repair weld No.SEG3020BB-019. The welder is identified as #066421. ABF QC is identified as Mr. Wang Xiang Ping. The welding variables recorded by QC appear to comply with WPS-345-FCAW-2G (2F)-FCM-REPAIR-1. The weld repair report is identified as CWR2752. The welding variables were recorded at, Amperage 270, volts 26 .The In-process FCAW appears to be progressing in compliance with approved contract documents. See Photo below
