**DEPARTMENT OF TRANSPORTATION**

Contract #: 04-0120F4Cty: SF/ALA Rte: 80 PM: 13.2/13.9File #: 69.28**WELDING INSPECTION REPORT****Resident Engineer:** Siegenthaler, Peter**Address:** 333 Burma Road**City:** Oakland, CA 94607**Report No:** WIR-024730**Date Inspected:** 14-Jun-2011**Project Name:** SAS Superstructure**OSM Arrival Time:** 1500**Prime Contractor:** American Bridge/Fluor Enterprises, a JV**OSM Departure Time:** 300**Contractor:** Zhenhua Port Machinery Company, Ltd (ZPMC), Changxing Island **Location:** Shanghai, China**CWI Name:** Mr. Li Yang ZPMC**CWI Present:** Yes No**Inspected CWI report:** Yes No N/A**Rod Oven in Use:** Yes No N/A**Electrode to specification:** Yes No N/A**Weld Procedures Followed:** Yes No N/A**Qualified Welders:** Yes No N/A**Verified Joint Fit-up:** Yes No N/A**Approved Drawings:** Yes No N/A**Approved WPS:** Yes No N/A**Delayed / Cancelled:** Yes No N/A**Bridge No:** 34-0006**Component:** TA Yard OBG 14W**Summary of Items Observed:**

**TRIAL ASSEMBLY****Magnetic Particle Testing (MT) / ABF Tracking**

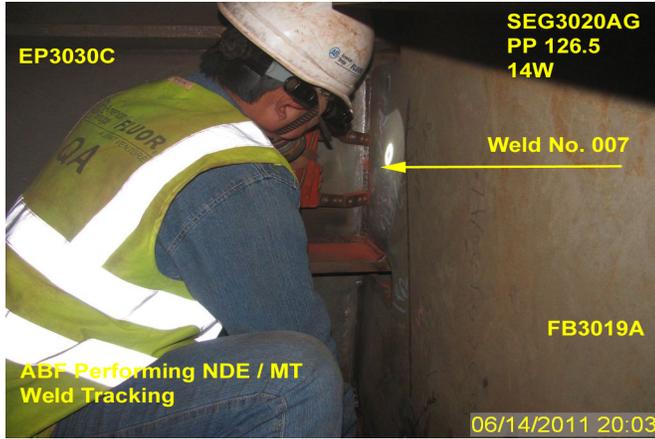
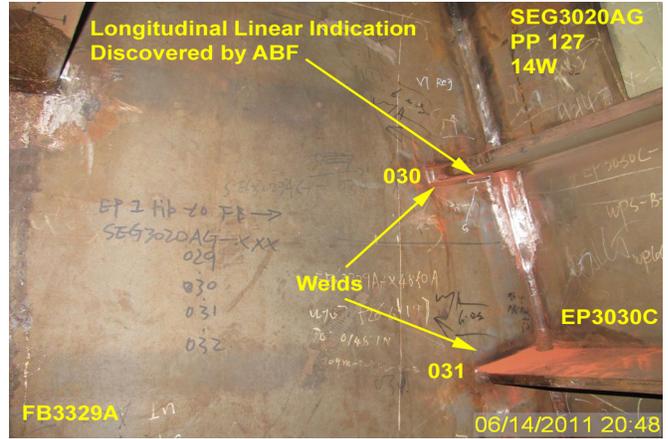
This QA inspector performed MT of approximately 15% of the area previously tested and accepted by ABF Quality Control / Quality Assurance personnel. This QA Inspector generated an MT report for this date. All components were as listed on NWIT notification no. 09480. The member(s) is/are identified as Lift 14W Edge Plate Rib Stiffener to Floor Beam and Rib Stiffener to Floor Beam. The weld designations reviewed are as follows:

SEG3020P-177, SEG3020P-179, SEG3020AG-031, SEG3020AL-183, SEG3020AL-188, SEG3020AL-193, SEG3020AL-198, SEG3020AL-248, SEG3020AL-253, SEG3020AL-258

Unless otherwise noted, all work observed on this date appeared to generally comply with applicable contract documents.
