DEPARTMENT OF TRANSPORTATION

Quality Assurance and Source Inspection

Contract #: 04-0120F4Cty: SF/ALA Rte: 80 PM: 13.2/13.9File #: 99.28**WELDING INSPECTION REPORT****Resident Engineer:** Siegenthaler, Peter**Address:** 333 Burma Road**City:** Oakland, CA 94607**Report No:** WIR-025284**Date Inspected:** 21-Jul-2011**Project Name:** SAS Superstructure**OSM Arrival Time:** 700**Prime Contractor:** American Bridge/Fluor Enterprises, a JV**OSM Departure Time:** 1900**Contractor:** Zhenhua Port Machinery Company, Ltd (ZPMC), Changxing Island **Location:** Shanghai**CWI Name:****CWI Present:****Yes No****Inspected CWI report:** Yes No N/A**Rod Oven in Use:****Yes No N/A****Electrode to specification:** Yes No N/A**Weld Procedures Followed:****Yes No N/A****Qualified Welders:** Yes No N/A**Verified Joint Fit-up:****Yes No N/A****Approved Drawings:** Yes No N/A**Approved WPS:****Yes No N/A****Delayed / Cancelled:****Yes No N/A****Bridge No:** 34-0006**Component:** OBG**Summary of Items Observed:**

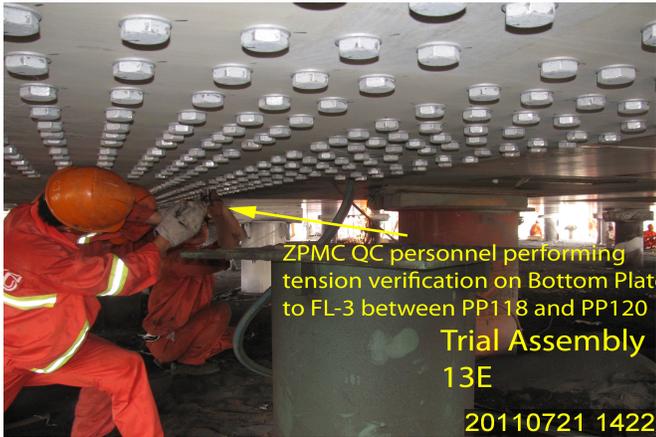
This QA Inspector witnessed the final bolt tension verification on bolts connecting the Bottom Plate to FL-3 at Panel Point (PP) 118 to Panel Point (PP) 120 Segment 13AE. The QA Inspector verified the bolt tension on a random basis and the results appeared to be in general compliance. The Inspection was performed in against Notification No. 00702 dated July 21, 2011.

The bolt sizes used were M24 x 95 RC Lot # DHGM240021 and the final torque value established was 540 N-m.
The bolt sizes used were M24 x 130 RC Lot # DHGM240128 and the final torque value established was 470 N-m.
The bolt sizes used were M24 x 170 RC Lot # DHGM240098 and the final torque value established was 620 N-m.
