DEPARTMENT OF TRANSPORTATION

Quality Assurance and Source Inspection

Contract #: 04-0120F4Cty: SF/ALA Rte: 80 PM: 13.2/13.9File #: 99.28**WELDING INSPECTION REPORT****Resident Engineer:** Siegenthaler, Peter**Address:** 333 Burma Road**City:** Oakland, CA 94607**Report No:** WIR-025514**Date Inspected:** 01-Aug-2011**Project Name:** SAS Superstructure**OSM Arrival Time:** 700**Prime Contractor:** American Bridge/Fluor Enterprises, a JV**OSM Departure Time:** 1900**Contractor:** Zhenhua Port Machinery Company, Ltd (ZPMC), Changxing Island **Location:** Shanghai**CWI Name:****CWI Present:**

Boat Lift 14E

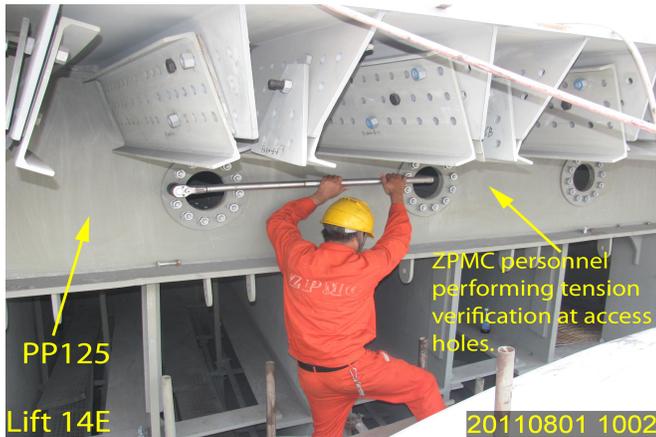
This QA Inspector witnessed the final bolt tension verification on bolts connecting connection plates as described below and at the locations listed below, The QA Inspector verified the bolt tension on a random basis and the results appeared to be in general compliance. The Inspection was performed against Notification No. 00726 dated August 1, 2011.

- PP121 to PP121.5 @ W14 inside Architectural Housing.
- PP122 to PP122.5 @ W14 inside Architectural Housing.
- PP125 Anchorage Plate elevation access holes.

The bolt sizes used were M24 x 75 RC Lot # DHGM240020 and the final torque value established was 600 N-m. The bolt sizes used were M27 x 95 RC Lot # DHGM270095 and the final torque value established was 641 N-m. 21 and the final torque value established was 383 N-m.
