Contract #: 04-0120F4Cty: SF/ALA Rte: 80 PM: 13.2/13.9File #: 99.28**WELDING INSPECTION REPORT****Resident Engineer:** Siegenthaler, Peter**Address:** 333 Burma Road**City:** Oakland, CA 94607**Report No:** WIR-025552**Date Inspected:** 30-Jun-2011**Project Name:** SAS Superstructure**OSM Arrival Time:** 1500**Prime Contractor:** American Bridge/Fluor Enterprises, a JV**OSM Departure Time:** 300**Contractor:** Zhenhua Port Machinery Company, Ltd (ZPMC) Changxing Island **Location:** Shanghai, China

BLAST INSPECTION

OBG Lift 14E

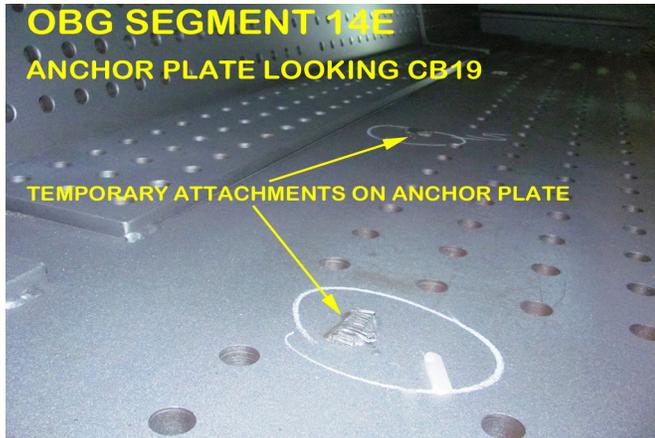
This Quality Assurance (QA) Inspector performed Post blast visual inspection (VT) of external surfaces of edge plate, anchor plates, bottom plates under CB and floor beams (FL3) in between PP126 to PP127 of the OBG 14E {CB Side}, Areas marked up for weld repair were recorded on a weld map for future repair. Areas requiring additional grinding were marked by QA and repaired by ZPMC personnel. For further information, please see the attached pictures below:
