**DEPARTMENT OF TRANSPORTATION**

Contract #: 04-0120F4Cty: SF/ALA Rte: 80 PM: 13.2/13.9File #: 69.28**WELDING INSPECTION REPORT****Resident Engineer:** Siegenthaler, Peter**Address:** 333 Burma Road**City:** Oakland, CA 94607**Report No:** WIR-025656**Date Inspected:** 17-Jul-2011**Project Name:** SAS Superstructure**OSM Arrival Time:** 1900**Prime Contractor:** American Bridge/Fluor Enterprises, a JV**OSM Departure Time:** 700**Contractor:** Zhenhua Port Machinery Company, Ltd (ZPMC), Changxing Island **Location:** Shanghai, China

# WELDING INSPECTION REPORT

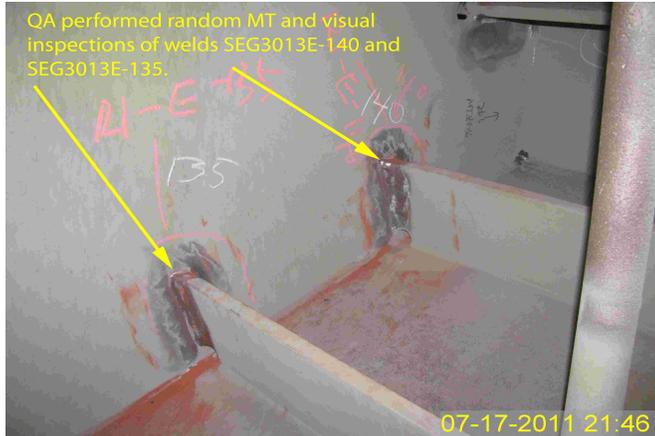
Caltrans and ABF have agreed to conduct visual and magnetic particle inspections (MT) of segment 13 West welds as part of a special inspection program, reference NWIT number 9764. This QA Inspector observed ABF Inspectors had completed and accepted MT inspections of welds: SEG3013C-012, 017, 029, 041, 085, 103, 138, 143, 149, 265, 267, 269, 272, 275, 277, 279, 282, 283, 284, 285; SEG3013E-039, 040, 044, 045, 049, 050, 070, 075, 085, 089, 090, 095, 099, 100, 124, 125, 135, 140, 173, 174, 176, 180, 183, 191, 192, 209, 225, 228, 231, 232, 233 and 237. This QA Inspector performed random visual and magnetic particle inspection of welds: SEG3013C-029, 041, 085, 103, 143, 265, 267, 269, 272, 277, 279, 282, 283, 284, 285; SEG3013E-040, 045, 050, 100, 135, 140, 225, 228, 231, 232, 233, 237, 304 and these welds appear to comply with AWS D1.5 MT and visual requirements. For additional information on these inspections see this QA Inspector's TL6028 Magnetic Particle Test Report.
