DEPARTMENT OF TRANSPORTATION

Quality Assurance and Source Inspection

Contract #: 04-0120F4Cty: SF/ALA Rte: 80 PM: 13.2/13.9File #: 99.28**WELDING INSPECTION REPORT****Resident Engineer:** Siegenthaler, Peter**Address:** 333 Burma Road**City:** Oakland, CA 94607**Report No:** WIR-025970**Date Inspected:** 07-Jul-2011**Project Name:** SAS Superstructure**OSM Arrival Time:** 700**Prime Contractor:** American Bridge/Fluor Enterprises, a JV**OSM Departure Time:** 1900**Contractor:** Zhenhua Port Machinery Company, Ltd (ZPMC) Chanxing Island**Location:** Shanghai, China**CWI Name:** Mr. LIU HUA JIE**CWI Present:** Yes No**Inspected CWI report:** Yes No N/A**Rod Oven in Use:** Yes No N/A**Electrode to specification:** Yes No N/A**Weld Procedures Followed:** Yes No N/A**Qualified Welders:** Yes No N/A**Verified Joint Fit-up:** Yes No N/A**Approved Drawings:** Yes No N/A**Approved WPS:** Yes No N/A**Delayed / Cancelled:** Yes No N/A**Bridge No:** 34-0006**Component:** OBG Segment**Summary of Items Observed:**

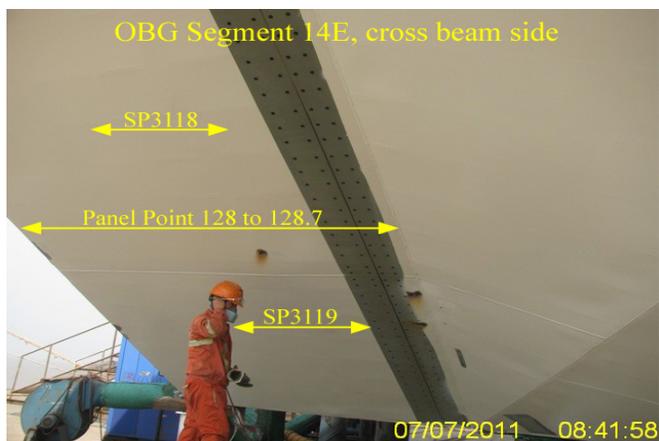
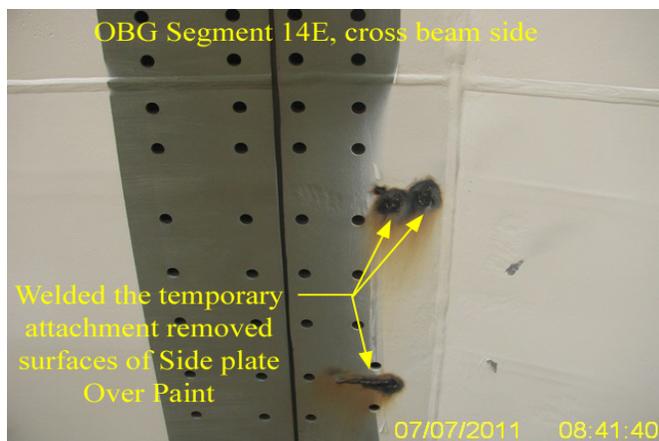
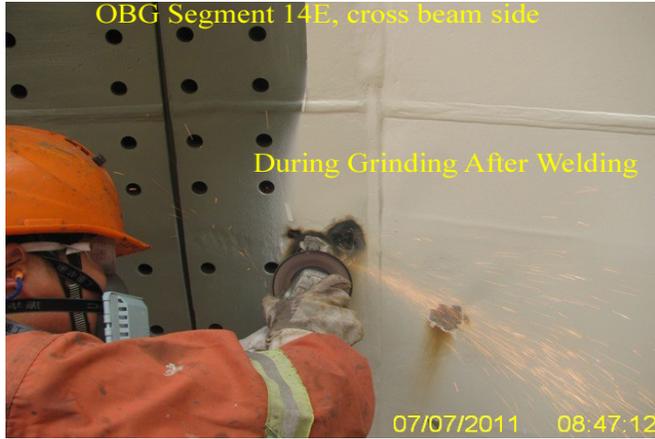
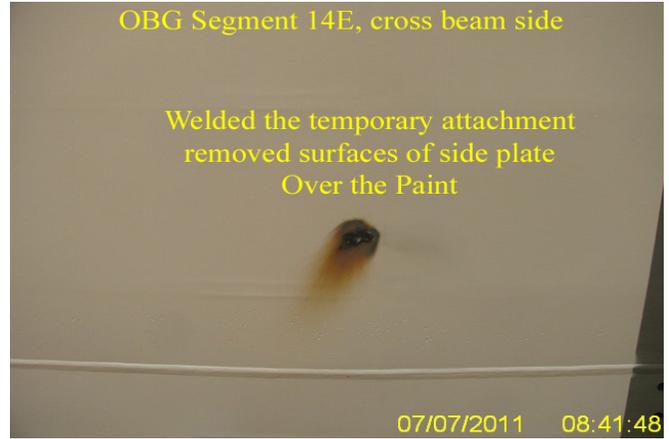
During Quality Assurance random Visual Inspection (VT) of side plate located on OBG Segment 14E at cross beam side, this Quality Assurance Inspector (QA) discovered the following issue. Base metal repair weld over the coated surface. This QA observed ZPMC welding personnel have performed base metal repair at temporary attachment removal sites prior to removing the paint. The repairs have been performed on side panels identified as SP3118 and SP3119. This QA observed this condition at four locations on the side panels located between panel points 128 to 128.7. The Side panels SP3118 and SP3119 are designated on the approved shop drawings as Seismic Performance Critical Members (SPCM). OBG Segment 14E is located at the Jetty-5. For further information please see the attached pictures below. This QA inspector generated a UT (TL-15) report on this date.
