Quality Assurance and Source Inspection

Contract #: 04-0120F4Cty: SF/ALA Rte: 80 PM: 13.2/13.9File #: 82.28**WELDING INSPECTION REPORT****Resident Engineer:** Siegenthaler, Peter**Address:** 333 Burma Road**City:** Oakland, CA 94607**Report No:** WIR-026220**Date Inspected:** 25-Aug-2011**Project Name:** SAS Superstructure**OSM Arrival Time:** 630**Prime Contractor:** American Bridge/Fluor Enterprises, a JV**OSM Departure Time:** 1500**Contractor:** Westmont Industries**Location:** Santa Fe Springs, CA**CWI Name:** Ruben Dominguez**CWI Present:** Yes No**Inspected CWI report:** Yes No N/A**Rod Oven in Use:** Yes No N/A**Electrode to specification:** Yes No N/A**Weld Procedures Followed:** Yes No N/A**Qualified Welders:** Yes No N/A**Verified Joint Fit-up:** Yes No N/A**Approved Drawings:** Yes No N/A**Approved WPS:** Yes No N/A**Delayed / Cancelled:** Yes No N/A**Bridge No:** 34-0006 L & R**Component:** Maintenance Travelers**Summary of Items Observed:**

WELDING INSPECTION REPORT

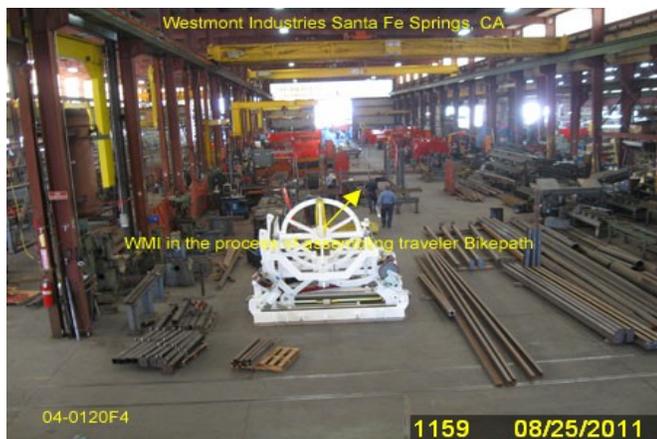
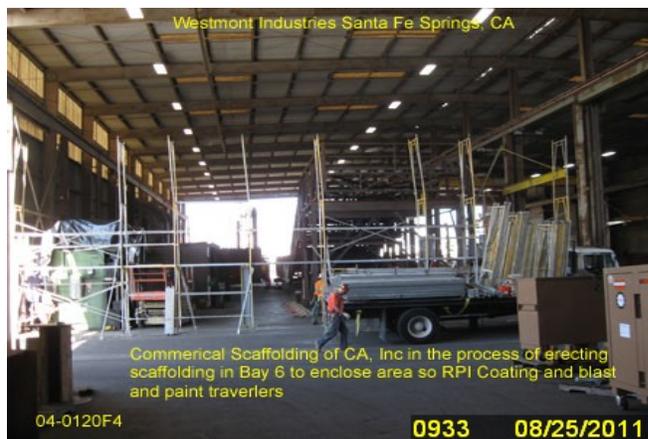
This QA Inspector observed that the activities mentioned above, appeared to be in compliance with the contract requirements and this QA Inspector observed no non-conforming issues, on this date.
