Contract #: 04-0120F4Cty: SF/ALA Rte: 80 PM: 13.2/13.9File #: 1.28**WELDING INSPECTION REPORT**

Report No: WIR-026282
Date Inspected: 13-Sep-2011

Project Name: SAS Superstructure
Prime Contractor: American Bridge/Fluor Enterprises, a JV
Contractor: American Bridge/Fluor Enterprises, a JV

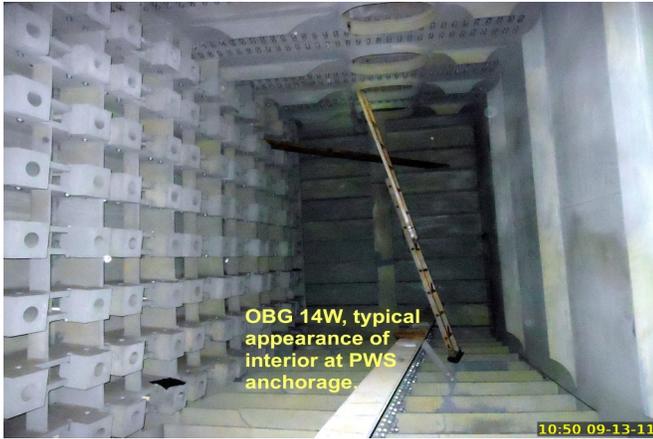
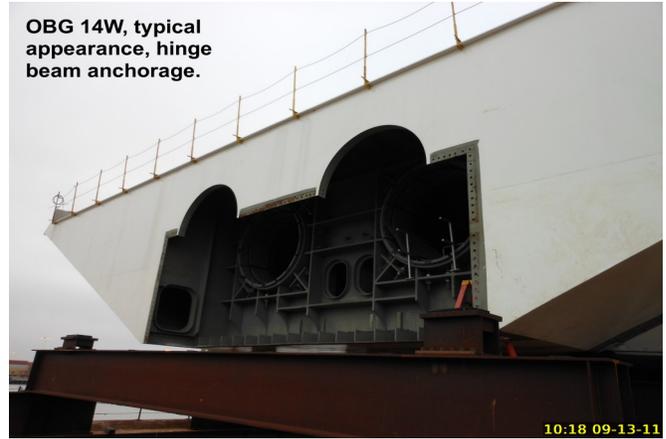
The QAI accompanied Caltrans representatives Tai Lin Liu, Thanh Le, Jason Wilcox and ABF representative Chuck Kanapicki in conducting the post arrival inspection of voyage 9 components. During the inspection, the QAI noted that painted surfaces have been marred from general shipping and handling and the contractor is aware of the necessary repairs. The QAI noted there does not appear to be other shipping related damage on OBG 14W. The QAI noted there are minor components that have not been examined for post arrival at this time. See the attached photos.
