Quality Assurance and Source Inspection

Contract #: 04-0120F4Cty: SF/ALA Rte: 80 PM: 13.2/13.9File #: 99.28**WELDING INSPECTION REPORT****Resident Engineer:** Siegenthaler, Peter**Address:** 333 Burma Road**City:** Oakland, CA 94607**Report No:** WIR-026362**Date Inspected:** 27-Mar-2011**Project Name:** SAS Superstructure**OSM Arrival Time:** 1500**Prime Contractor:** American Bridge/Fluor Enterprises, a JV**OSM Departure Time:** 300**Contractor:** Zhenhua Port Machinery Company, Ltd (ZPMC) Changxing Island **Location:** Shanghai, China**CWI Name:** Lv Li Qing**CWI Present:** Yes No**Inspected CWI report:** Yes No N/A**Rod Oven in Use:** Yes No N/A**Electrode to specification:** Yes No N/A**Weld Procedures Followed:** Yes No N/A**Qualified Welders:** Yes No N/A**Verified Joint Fit-up:** Yes No N/A**Approved Drawings:** Yes No N/A**Approved WPS:** Yes No N/A**Delayed / Cancelled:** Yes No N/A**Bridge No:** 34-0006**Component:** OBG**Summary of Items Observed:**

OBG Bay 14

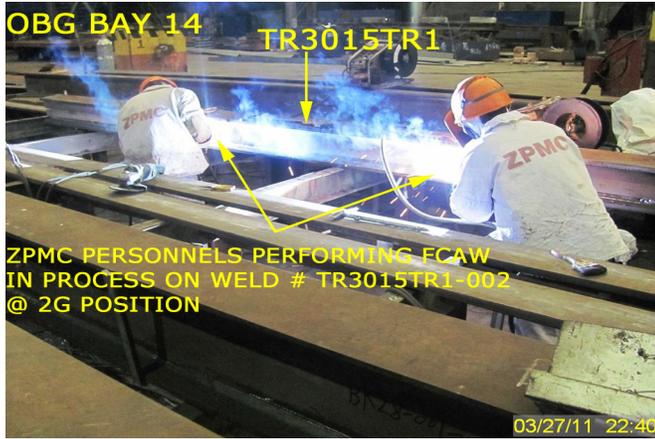
This QA Inspector observed the welding operation per the FCAW process on a weld joint identified as TR3015TR1-002 located on traveler rail. The welders are identified as 201215 and 066734. ZPMC Quality Control (QC) is identified as Mr. Wang Xiang Pin. The welding variables recorded by QC appeared to comply with WPS-B-T-2232-ESAB. For more details please see attached photo below:
