**DEPARTMENT OF TRANSPORTATION**

Contract #: 04-0120F4Cty: SF/ALA Rte: 80 PM: 13.2/13.9File #: 82.28**WELDING INSPECTION REPORT****Resident Engineer:** Casey, William**Address:** 333 Burma Road**City:** Oakland, CA 94607**Report No:** WIR-026396**Date Inspected:** 16-Sep-2011**Project Name:** SAS Superstructure**OSM Arrival Time:** 600**Prime Contractor:** American Bridge/Fluor Enterprises, a JV**OSM Departure Time:** 1430**Contractor:** Westmont Industries**Location:** Santa Fe Springs, CA**CWI Name:** Ruben Dominguez**CWI Present:** Yes No**Inspected CWI report:** Yes No N/A**Rod Oven in Use:** Yes No N/A**Electrode to specification:** Yes No N/A**Weld Procedures Followed:** Yes No N/A**Qualified Welders:** Yes No N/A**Verified Joint Fit-up:** Yes No N/A**Approved Drawings:** Yes No N/A**Approved WPS:** Yes No N/A**Delayed / Cancelled:** Yes No N/A**Bridge No:** 34-0006 L & R**Component:** Maintenance Travelers**Summary of Items Observed:**

**E2/E3-WB Traveler (South) & (North)**

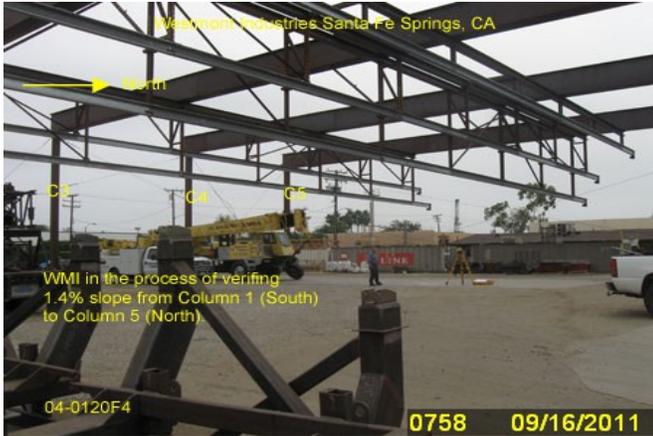
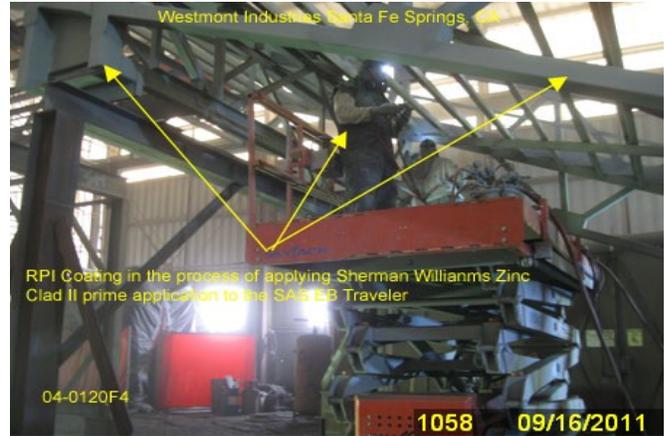
This QA Inspector randomly observed WMI production welder Mr. Eutimo Lopez (WID # 3035) continuing to perform Flux Core Arc Welding (FCAW) activities on the E2/E3-WB Traveler Assemblies. This QA Inspector observed Mr. Lopez performing the FCAW in all positions on tube steel and plate material, randomly throughout the shift.

This QA Inspector randomly observed WMI production personnel Mr. Charles Newton WID#3200, continuing to perform Flux Core Arc Welding (FCAW) activities on the E2/E3-WB Traveler Assemblies. This QA Inspector observed Mr. Newton performing the FCAW in all positions on tube steel and plate material, randomly throughout the shift. Note: Welding completed on the E2/E3 Traveler on this date

Note: This QA Inspector randomly observed WMI CWI QC Ray Anaya and Smith Emery CWI QC Inspector performing final inspection on the E2/E3 WB Traveler.

This QA Inspector performed random shop observations and observed that RPI Coating is on site to continue sweep blast and apply the prime coat application on the SAS EB Traveler. QA Inspector was informed by RPI Coating Quality Control (QC) Representative Mr. Preston Keen that RPI is going to sweep blast a another section and apply the Sherman Williams Zinc Clad II prime coat to the today. Later in the morning this QA Inspector randomly observed that RPI personnel performing sweep blasting activities on the SAS EB Traveler. After sweep blasting was completed, QA Inspector then observed Mr. Keen performing random surface profile checks on the sweep blasted base metal surfaces. This QA Inspector observed Mr. Keen utilizing a Testex Press-O-Film and a micrometer to perform the testing. During observation, this QA Inspector observed that the readings appeared to be 3.3 mils, 3.2 mils, and 3.6 mils. Testing observed by QA Inspector appears to be in compliance with the contract requirements. After testing was completed this QA observed RPI Coating personnel masking areas to prevent overspray.

Later in the shift, this QA Inspector randomly observed RPI Coating performing what appeared to be primer application activities within what appeared to be within an 8 hour time frame from the above mentioned sweep blasting activities. Environmental readings taken by RPI at the time of primer application are as follows Air Temperature 84 F, Relative Humidity 45%, Wet Bulb Temperature 57 F, Dew point 65 F and Surface Temperature 83 F.

QA Inspector performed measurement on dry coating thickness with Type 2 (magnetic gage), DFT's thickness reading of the prime coated section coated on 09-15-11 are an average of three (3) thickness reading are as follows 4.5 mils, 4.8 mils, 4.9 mils 5.8 mils, 5.8 mils, 4.3 mils, 3.6 mils, and 3.3 mils. QA Inspector also, observed Mr. Keen documenting daily activities on RPI Coating QC Daily Inspection Report. Note: Also see QA Inspector Fintan Shanley Caltrans 6034 report for this date.
