Contract #: 04-0120F4Cty: SF/ALA Rte: 80 PM: 13.2/13.9File #: 82.28**WELDING INSPECTION REPORT****Resident Engineer:** Casey, William**Address:** 333 Burma Road**City:** Oakland, CA 94607**Report No:** WIR-026428**Date Inspected:** 20-Sep-2011**Project Name:** SAS Superstructure**OSM Arrival Time:** 600**Prime Contractor:** American Bridge/Fluor Enterprises, a JV**OSM Departure Time:** 1430**Contractor:** Westmont Industries**Location:** Santa Fe Springs, CA**CWI Name:** Patrick Fitzgerald**CWI Present:** Yes No**Inspected CWI report:** Yes No N/A**Rod Oven in Use:** Yes No N/A**Electrode to specification:** Yes No N/A**Weld Procedures Followed:** Yes No N/A**Qualified Welders:** Yes No N/A**Verified Joint Fit-up:** Yes No N/A**Approved Drawings:** Yes No N/A**Approved WPS:** Yes No N/A**Delayed / Cancelled:** Yes No N/A**Bridge No:** 34-0006 L & R**Component:** Maintenance Travelers**Summary of Items Observed:**

WELDING INSPECTION REPORT

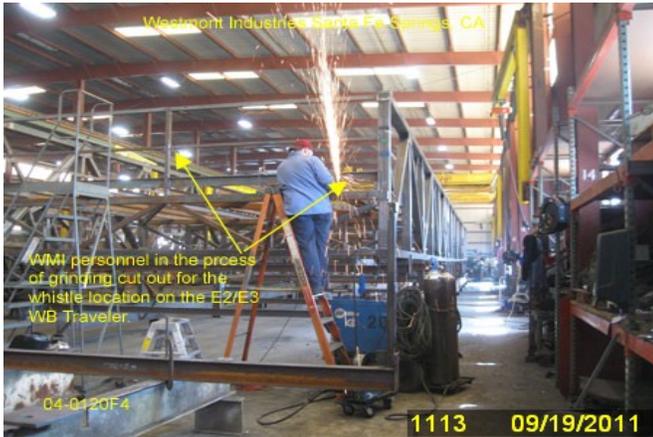
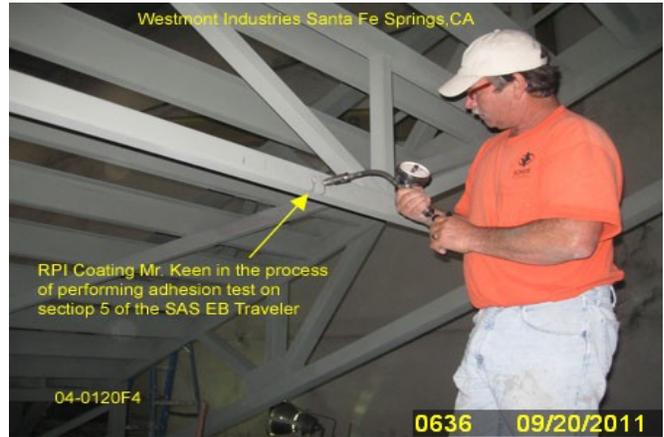
Prime coated on 9-16-11 (section 5), adhesion retest 435 psi, 450 psi, 400 psi, 400 psi (fail- paint), Pencil Test (pass), Quarter Test (pass) and Rub test (pass).

QA Inspector informed SMR Mr. Nicolai Hvass and QA Inspector Mr. Fintan Shanley of the above failing test results information. Mr. Hvass and Mr. Shanley stated that areas with failing test results should be re-blasted and re-primed. QA Inspector informed Mr. Keen that due to failing adhesion tests being below the required 580 psi/ 4 MPa that the entire area for that day of production will need to be re-blasted and re-primed. Mr. Keen stated that he would like to glue additional dollies and perform the adhesion testing tomorrow. QA observed Mr. Keen glue

additional dollies in the area of 9-16-11 production.
