Contract #: 04-0120F4Cty: SF/ALA Rte: 80 PM: 13.2/13.9File #: 1x.28**WELDING INSPECTION REPORT****Resident Engineer:** Casey, William**Address:** 333 Burma Road**City:** Oakland, CA 94607**Report No:** WIR-026586**Date Inspected:** 29-Oct-2011**Project Name:** SAS Superstructure**OSM Arrival Time:** 630**Prime Contractor:** American Bridge/Fluor Enterprises, a JV**OSM Departure Time:** 1530**Contractor:** American Bridge/Fluor Enterprises, a JV**Location:** Onsite**CWI Name:** Pat Swain**CWI Present:** Yes No**Inspected CWI report:** Yes No N/A**Rod Oven in Use:** Yes No N/A**Electrode to specification:** Yes No N/A**Weld Procedures Followed:** Yes No N/A**Qualified Welders:** Yes No N/A**Verified Joint Fit-up:** Yes No N/A**Approved Drawings:** Yes No N/A**Approved WPS:** Yes No N/A**Delayed / Cancelled:** Yes No N/A**Bridge No:** 34-0006**Component:** OBG Sections**Summary of Items Observed:**

OBG Deck Plate Section 12W ~ 13W:

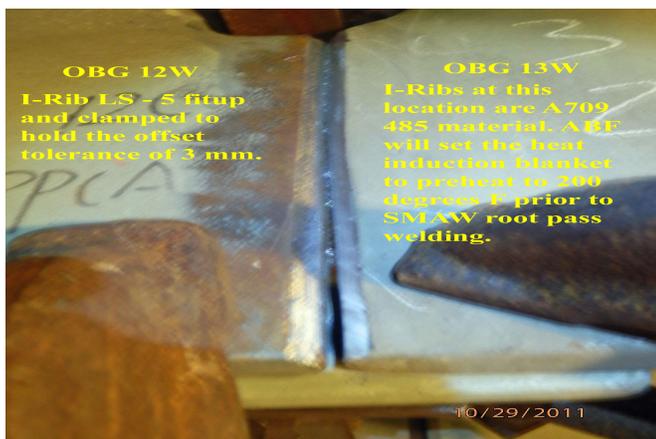
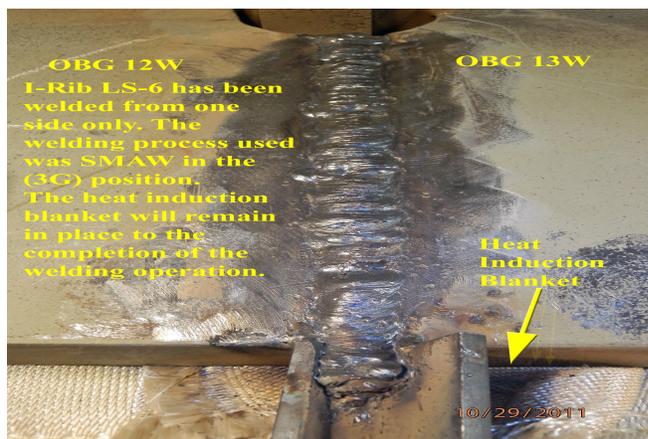
This QA Inspector randomly observed ABF welder Mr. Fred Kaddu (Welder ID 2188) performing the cover pass weld operation per the SMAW process in the (3G) Vertical position on I-Rib Longitudinal Stiffener (LS-6) on the inside of OBG Deck Plate Section 12W ~ 13W. At this location, the I-Rib LS is A709 GR. 485 material. This QA Inspector observed QC Inspector Mr. Pat Swain verify prior to the start of the welding operation that the welding parameters (Amps, Volts, and Travel Speed) and preheat temperature were in accordance with WPS -D1.5 1012-3 Revision 0. This QA Inspector verified that the 9018M electrodes being used to perform the cover pass weld operation were stored and removed from a heated quiver. This QA Inspector observed that ABF welder Mr. Kaddu completed only one side of the double V groove weld at this location. The heat induction blanket remained in place on the opposite side of the weld joint and the temperature of the weld and surrounding base metal were held at a temperature of 200 degrees F.

This QA Inspector randomly observed ABF welder Mr. Fred Kaddu (Welder ID 2188) setting up to perform the root pass welding per the SMAW process in the (3G) Vertical position on I-Rib Longitudinal Stiffener (LS-5) on the inside of OBG Deck Plate Section 12W ~ 13W. At this location the I-Rib LS is A709 GR. 485 material. This QA Inspector observed that ABF QC Inspector Mr. Tony Sherwood previously measured the offset between I-Rib

LS plates and the offset measured was 3 mm. The thickness of LS-5 stiffener is 30 mm. The allowable offset tolerance at this location is 3 mm. This QA Inspector observed the use bridge clamps to hold the offset between the two I-Rib LS plates to within the 3 mm tolerance prior to the start of the root pass weld operation. ABF welder Mr. Kaddu placed the heat induction blanket across the weld joint to start the preheat operation and once the preheat temperature of 200 Degrees F was reached, Mr. Kaddu was ready to perform the root pass weld operation per the SMAW process in the (3G) Vertical position using 1/8" diameter 9018M electrode. This QA Inspector verified that the 9018M electrodes being used to perform the root pass weld operation were stored and removed from a heated quiver. This QA Inspector also observed QC Inspector Mr. Pat Swain verify prior to the start of the root pass weld operation that the welding parameters and preheat temperature were in accordance with WPS-D1.5 1012-3 Revision 0 on I-Rib LS-5. The root pass weld operation was partially completed along the 230 mm weld length of LS-5 and afterwards this QA Inspector observed ABF welder Mr. Kaddu remove the bridge clamps to complete the root pass weld operation for the full length of the weld joint. The root pass weld operation was in-process at the end of the QA Inspectors' shift and QC Inspector Mr. Pat Swain will stay at the location to monitor the completion of the root pass weld operation.
