Contract #: 04-0120F4Cty: SF/ALA Rte: 80 PM: 13.2/13.9File #: 82.28**WELDING INSPECTION REPORT**

Report No: WIR-026661
Date Inspected: 05-Nov-2011

Project Name: SAS Superstructure
Prime Contractor: American Bridge/Fluor Enterprises, a JV
Contractor: Westmont Industries

CWI Name:	Chris Concha, Ruben Gonzaez	CWI Present:	Yes	No
Inspected CWI report:	Yes No N/A	Rod Oven in Use:	Yes	No N/A
Electrode to specification:	Yes No N/A	Weld Procedures Followed:	Yes	No N/A
Qualified Welders:	Yes No N/A	Verified Joint Fit-up:	Yes	No N/A
Approved Drawings:	Yes No N/A	Approved WPS:	Yes	No N/A
		Delayed / Cancelled:	Yes	No N/A
Bridge No:	34-0006	Component:	Maintenance Travelers

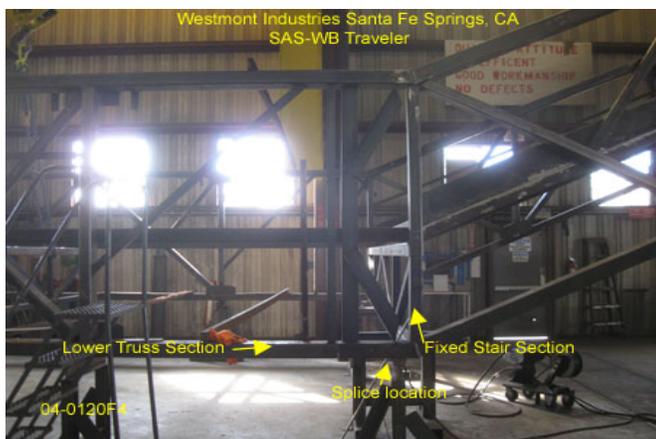
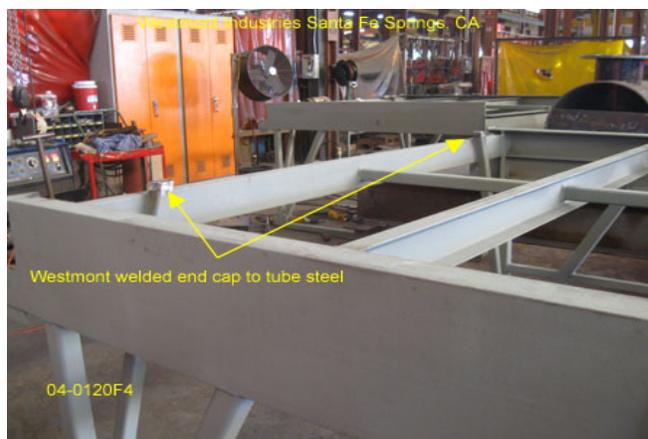
Repair of Dented Truss Members on the E2/E3-WB Traveler (South end)

This QA Inspector witnessed Smith Emery, CWI, QC Inspector Mr. Ruben Dominguez perform Visual Inspection (VT) and 100% Ultrasonic Inspection (UT) on Assembly 8-A427 bottom chord (South End) splice repair, weld joints SR#1 and SR#2. Mr. Dominguez informed QA that he found no relevant indications in either of the two (2) splice welds. Upon completion of the QC Inspectors inspection this QA Inspector performed 100% VT and 25% (UT). See Caltrans Ultrasonic Test Report, TL-6027 dated November 5, 2011 for additional information. Also, see contract document ABF-RFI-002619R00 dated October 27, 2011.
