DEPARTMENT OF TRANSPORTATION

Quality Assurance and Source Inspection

Contract #: 04-0120F4Cty: SF/ALA Rte: 80 PM: 13.2/13.9File #: 1.28**WELDING INSPECTION REPORT****Resident Engineer:** Casey, William**Address:** 333 Burma Road**City:** Oakland, CA 94607**Report No:** WIR-026682**Date Inspected:** 10-Nov-2011**Project Name:** SAS Superstructure**OSM Arrival Time:** 700**Prime Contractor:** American Bridge/Fluor Enterprises, a JV**OSM Departure Time:** 1530**Contractor:** American Bridge/Fluor Enterprises, a JV**Location:** Job Site**CWI Name:** As noted below.**CWI Present:** Yes No**Inspected CWI report:** Yes No N/A**Rod Oven in Use:** Yes No N/A**Electrode to specification:** Yes No N/A**Weld Procedures Followed:** Yes No N/A**Qualified Welders:** Yes No N/A**Verified Joint Fit-up:** Yes No N/A**Approved Drawings:** Yes No N/A**Approved WPS:** Yes No N/A**Delayed / Cancelled:** Yes No N/A**Bridge No:** 34-0006**Component:** OBG Component**Summary of Items Observed:**

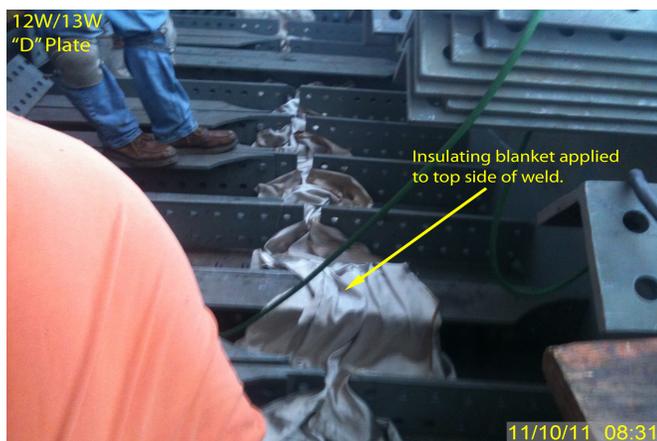
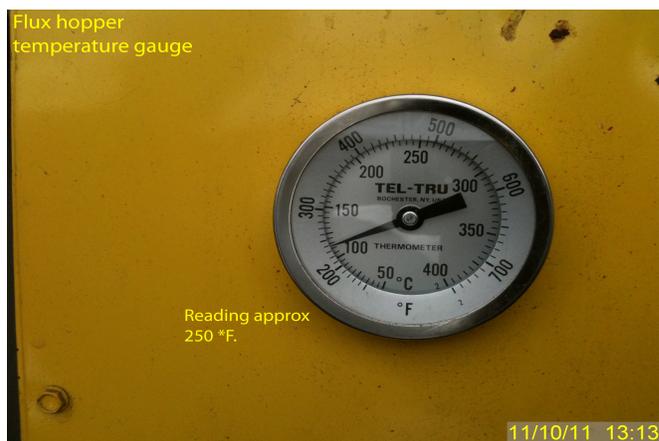
Approximately 13:15 this QA randomly observed ABF/JV personnel adding Submerged Arc Welding (SAW) flux to the hopper located at the 12W/13W weld joint location. This QA randomly observed the temperature gauge attached to this flux hopper indicating approximately (250*F). See attached photograph for visual representation.
