Contract #: 04-0120F4Cty: SF/ALA Rte: 80 PM: 13.2/13.9File #: 1.28**WELDING INSPECTION REPORT****Resident Engineer:** Casey, William**Address:** 333 Burma Road**City:** Oakland, CA 94607**Report No:** WIR-026683**Date Inspected:** 10-Nov-2011**Project Name:** SAS Superstructure**OSM Arrival Time:** 700**Prime Contractor:** American Bridge/Fluor Enterprises, a JV**OSM Departure Time:** 1730**Contractor:** American Bridge/Fluor Enterprises, a JV**Location:** Job Site**CWI Name:** William Sherwood**CWI Present:** Yes No**Inspected CWI report:** Yes No N/A**Rod Oven in Use:** Yes No N/A**Electrode to specification:** Yes No N/A**Weld Procedures Followed:** Yes No N/A**Qualified Welders:** Yes No N/A**Verified Joint Fit-up:** Yes No N/A**Approved Drawings:** Yes No N/A**Approved WPS:** Yes No N/A**Delayed / Cancelled:** Yes No N/A**Bridge No:** 34-0006**Component:** SAS OBG**Summary of Items Observed:**

WELDING INSPECTION REPORT

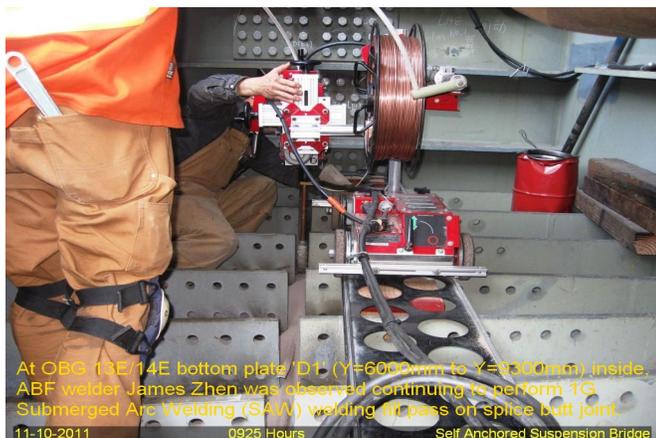
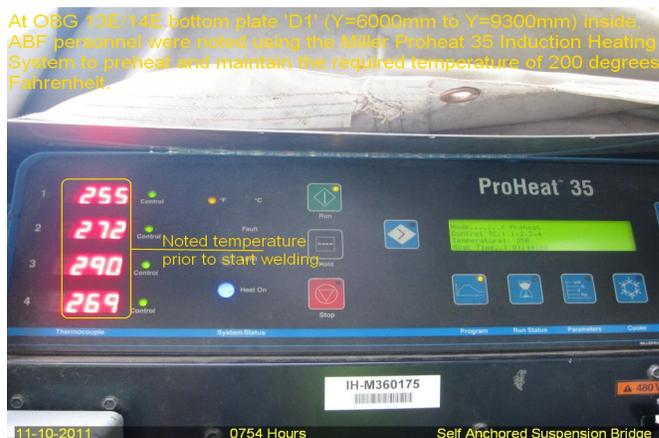
At OBG 13E/14E bottom plate 'D1' (Y=6000mm to Y=9300mm) inside, QA randomly observed ABF certified welder James Zhen ID #6001 continuing to perform 1G (flat position) Submerged Arc Welding (SAW) welding fill pass to cover pass on the unequal plate thickness (35mm/30mm) Complete Joint Penetration (CJP) splice butt joint. The welder was utilizing F7A6-EM12K-H8, 3.2mm electrode with corresponding Esab OK Flux 10.62 flux and implementing Caltrans approved Welding Procedure Specification (WPS) ABF-WPS-D15-4042B-1. The Seismic Performance Critical Member (SPCM) joint being welded has a single V-groove butt joint with backing bar that will be removed then back welded. The plates were preheated to more than 200 degree Fahrenheit using Miller Proheat 35 Induction Heating System heater blankets located at the opposite side of the plate prior/during welding. Welding parameters were monitored by ABF/QC Bernie Docena. QA noted the welding parameters, the workmanship and appearance of the completed fill pass deemed satisfactory. At the end of the shift, cover pass welding was completed and the welder has held the preheat of more than 200°F for three more hours after welding as required.

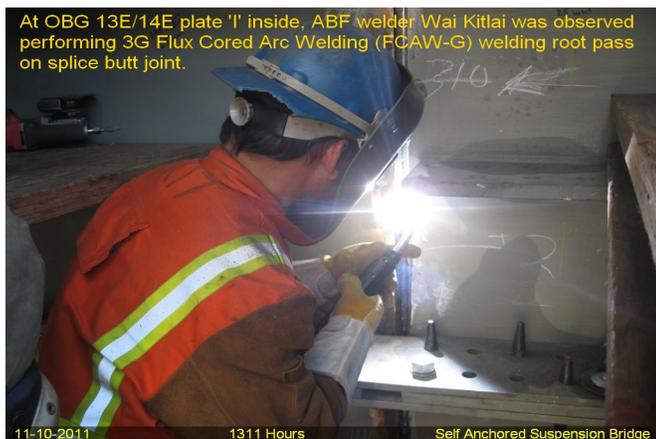
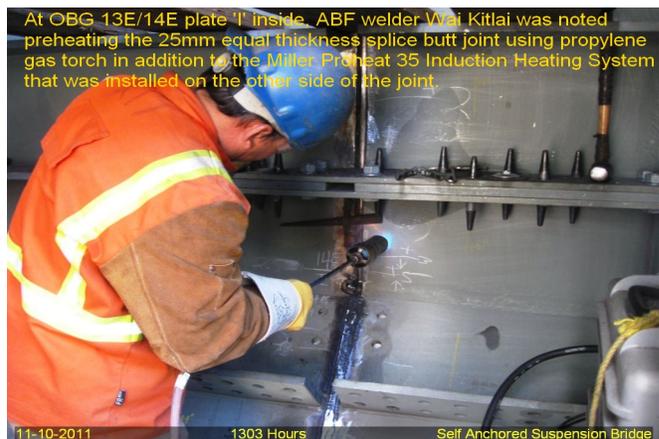
At OBG 13E/14E vertical plate 'I' inside, QA randomly observed ABF/JV qualified welder Wai Kitlai perform root pass to fill pass welding on the Complete Joint Penetration (CJP) splice butt joint. The welder was observed manually welding in the 3G (vertical) position utilizing a Flux Cored Arc Welding (FCAW-G) with E71T-1M, 1/16" diameter wire electrode and implementing Caltrans approved Welding Procedure Specification (WPS)

ABF-WPS-D15-3040B-3. The 25mm equal thickness Seismic Performance Critical Member (SPCM) joint being welded has a single V-groove butt joint with backing bar that will be removed and back gouged then back welded. During welding, ABF Quality Control (QC) William Sherwood was noted monitoring the welding parameters of the welder. Measured parameters during welding were 258 amperes, 24.1 volts and travel speed of 170mm per minute with calculated heat input of 2.19 Kjoules/mm which deemed in compliance to the contract requirements. During the shift, fill pass FCAW-G welding was still continuing and should remain tomorrow.
