Contract #: 04-0120F4Cty: SF/ALA Rte: 80 PM: 13.2/13.9File #: 82.28**WELDING INSPECTION REPORT****Resident Engineer:** Casey, William**Address:** 333 Burma Road**City:** Oakland, CA 94607**Report No:** WIR-026706**Date Inspected:** 11-Nov-2011**Project Name:** SAS Superstructure**OSM Arrival Time:** 600**Prime Contractor:** American Bridge/Fluor Enterprises, a JV**OSM Departure Time:** 1430**Contractor:** Westmont Industries**Location:** Santa Fe Springs, CA**CWI Name:** Chris Concha**CWI Present:** Yes No**Inspected CWI report:** Yes No N/A**Rod Oven in Use:** Yes No N/A**Electrode to specification:** Yes No N/A**Weld Procedures Followed:** Yes No N/A**Qualified Welders:** Yes No N/A**Verified Joint Fit-up:** Yes No N/A**Approved Drawings:** Yes No N/A**Approved WPS:** Yes No N/A**Delayed / Cancelled:** Yes No N/A**Bridge No:** 34-0006**Component:** Maintenance Travelers**Summary of Items Observed:**

**Miscellaneous Traveler Modifications**

# WELDING INSPECTION REPORT

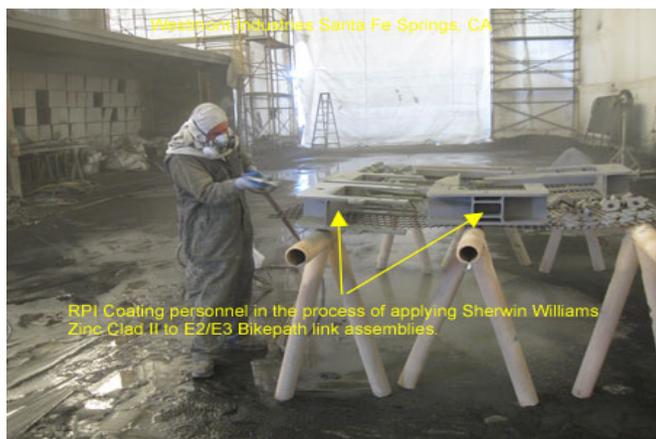
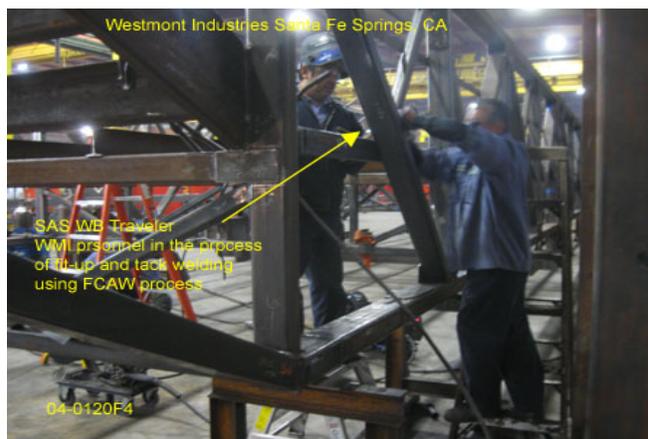
This QA Inspector randomly observed CSI moving the E2/E3 WB Traveler out of bay 6 to outside under the test rack. This QA Inspector performed random shop observations and observed that RPI is on site and starting coating application on the Bike Path link assemblies. QA Inspector was informed by RPI Coating Mr. Silviano Hernandez that RPI is going abrasive blast bike path link assemblies and apply the Sherwin Williams Zinc Clad II. After abrasive blasting was completed, QA Inspector then observed Mr. Hernandez performing what appeared to be random surface profile checks on the abrasive blasted base metal surfaces. This QA Inspector observed Mr. Hernandez utilizing a Testex Press-O-Film and a micrometer to perform the testing. This QA Inspector then observed Mr. Hernandez utilize a micrometer to measure the surface profile on the clear film part of the strip, in which the rubbing was performed. During observation, this QA Inspector observed that the readings appeared to be 3.4 mils. This QA Inspector was then informed by Mr. Hernandez that primer application will soon start. Later in the shift, this QA Inspector randomly observed RPI Coating performing what appeared to be primer application activities within what appeared to be within and 8 hour time frame from the above mentioned blasting activities. Environmental readings taken by RPI at the time of coating application are as follows: Air Temperature 77 F, Relative Humidity 40%, Wet Bulb Temperature 62 F, Dew point 50 F and Surface Temperature 83 F.
