**DEPARTMENT OF TRANSPORTATION**

Contract #: 04-0120F4Cty: SF/ALA Rte: 80 PM: 13.2/13.9File #: 1.28**WELDING INSPECTION REPORT****Resident Engineer:** Casey, William**Address:** 333 Burma Road**City:** Oakland, CA 94607**Report No:** WIR-026767**Date Inspected:** 28-Nov-2011**Project Name:** SAS Superstructure**OSM Arrival Time:** 730**Prime Contractor:** American Bridge/Fluor Enterprises, a JV**OSM Departure Time:** 1600**Contractor:** American Bridge/Fluor Enterprises, a JV**Location:** Job Site**CWI Name:** N / A**CWI Present:** Yes No**Inspected CWI report:** Yes No N/A**Rod Oven in Use:** Yes No N/A**Electrode to specification:** Yes No N/A**Weld Procedures Followed:** Yes No N/A**Qualified Welders:** Yes No N/A**Verified Joint Fit-up:** Yes No N/A**Approved Drawings:** Yes No N/A**Approved WPS:** Yes No N/A**Delayed / Cancelled:** Yes No N/A**Bridge No:** 34-0006**Component:** S.A.S. components**Summary of Items Observed:**

## WELDING INSPECTION REPORT

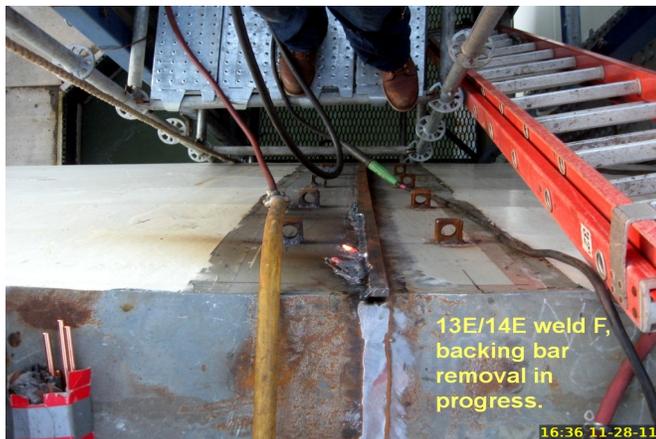
3) The QAI observed ABF personnel removing the backing bar from the exterior side of weld F on the 13E/14E field splice. The QAI noted that Fred Kaddu, ID 2188, is using carbon arc gouging to remove the backing bar to prepare the CJP field splice for back welding. The work was in progress until the end of the shift and was not completed. See the attached photo.
