**DEPARTMENT OF TRANSPORTATION**

Contract #: 04-0120F4Cty: SF/ALA Rte: 80 PM: 13.2/13.9File #: 82.28**WELDING INSPECTION REPORT****Resident Engineer:** Casey, William**Address:** 333 Burma Road**City:** Oakland, CA 94607**Report No:** WIR-026875**Date Inspected:** 12-Dec-2011**Project Name:** SAS Superstructure**OSM Arrival Time:** 600**Prime Contractor:** American Bridge/Fluor Enterprises, a JV**OSM Departure Time:** 1430**Contractor:** Westmont Industries**Location:** Santa Fe Springs, CA**CWI Name:** Chris Concha**CWI Present:** Yes No**Inspected CWI report:** Yes No N/A**Rod Oven in Use:** Yes No N/A**Electrode to specification:** Yes No N/A**Weld Procedures Followed:** Yes No N/A**Qualified Welders:** Yes No N/A**Verified Joint Fit-up:** Yes No N/A**Approved Drawings:** Yes No N/A**Approved WPS:** Yes No N/A**Delayed / Cancelled:** Yes No N/A**Bridge No:** 34-0006**Component:** Maintenance Travelers**Summary of Items Observed:**

# WELDING INSPECTION REPORT

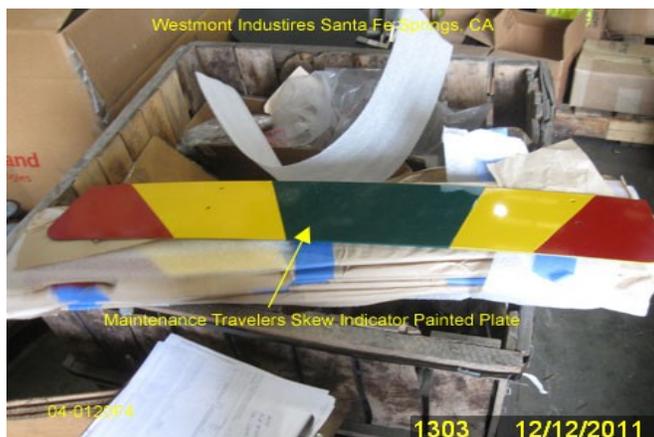
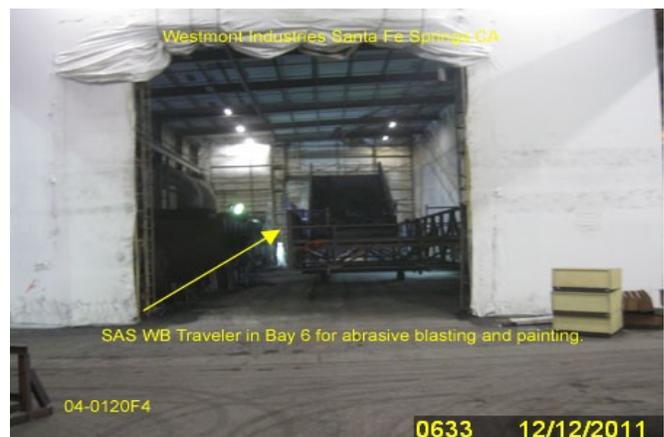
This QA Inspector performed random shop observations and observed that RPI Coating is on site to start abrasive blasting on the SAS WB Traveler. This QA randomly observed RPI Coating in the process of abrasive blasting.

This QA noted above items observed appear to comply with contract documents.
