DEPARTMENT OF TRANSPORTATION

Quality Assurance and Source Inspection

Contract #: 04-0120F4Cty: SF/ALA Rte: 80 PM: 13.2/13.9File #: 82.28**WELDING INSPECTION REPORT****Resident Engineer:** Casey, William**Address:** 333 Burma Road**City:** Oakland, CA 94607**Report No:** WIR-026950**Date Inspected:** 23-Dec-2011**Project Name:** SAS Superstructure**Prime Contractor:** American Bridge/Fluor Enterprises, a JV**Contractor:** Westmont Industries**OSM Arrival Time:** 500**OSM Departure Time:** 1000**Location:** Santa Fe Springs, CA**CWI Name:** Chris Concha**CWI Present:** Yes No**Inspected CWI report:** Yes No N/A**Rod Oven in Use:** Yes No N/A**Electrode to specification:** Yes No N/A**Weld Procedures Followed:** Yes No N/A**Qualified Welders:** Yes No N/A**Verified Joint Fit-up:** Yes No N/A**Approved Drawings:** Yes No N/A**Approved WPS:** Yes No N/A**Delayed / Cancelled:** Yes No N/A**Bridge No:** 34-0006**Component:** Maintenance Travelers**Summary of Items Observed:**

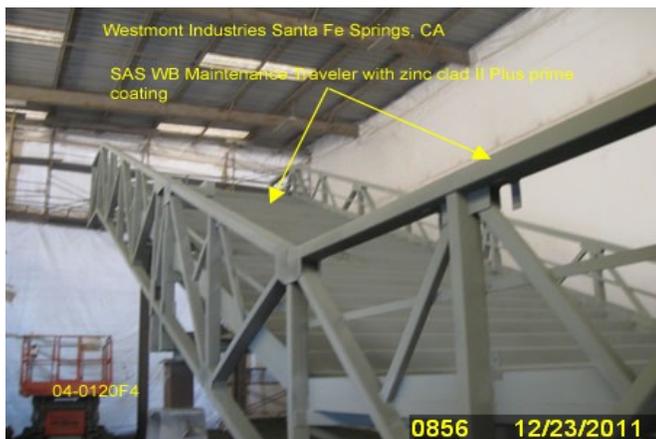
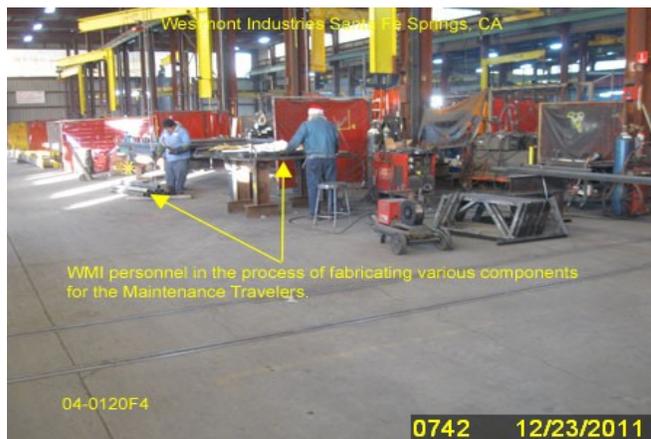
Representative Mr. Preston Keen that RPI is going to reapply the Sherwin Williams Zinc Clad II prime coating on the fixed stair section today. Later in the morning this QA observed RPI Coating applying additional Zinc Clad II prime coating on the fixed stair due to overall average was not in compliance with the contract requirements of 90 microns to 150 microns.

This QA noted above items observed appear to comply with contract documents.
