DEPARTMENT OF TRANSPORTATION

Quality Assurance and Source Inspection

Contract #: 04-0120F4Cty: SF/ALA Rte: 80 PM: 13.2/13.9File #: 82.28**WELDING INSPECTION REPORT****Resident Engineer:** Casey, William**Address:** 333 Burma Road**City:** Oakland, CA 94607**Report No:** WIR-026963**Date Inspected:** 27-Dec-2011**Project Name:** SAS Superstructure**OSM Arrival Time:** 600**Prime Contractor:** American Bridge/Fluor Enterprises, a JV**OSM Departure Time:** 1430**Contractor:** Westmont Industries**Location:** Santa Fe Springs, CA**CWI Name:** Chris Concha**CWI Present:** Yes No**Inspected CWI report:** Yes No N/A**Rod Oven in Use:** Yes No N/A**Electrode to specification:** Yes No N/A**Weld Procedures Followed:** Yes No N/A**Qualified Welders:** Yes No N/A**Verified Joint Fit-up:** Yes No N/A**Approved Drawings:** Yes No N/A**Approved WPS:** Yes No N/A**Delayed / Cancelled:** Yes No N/A**Bridge No:** 34-0006**Component:** Maintenance Travelers**Summary of Items Observed:**

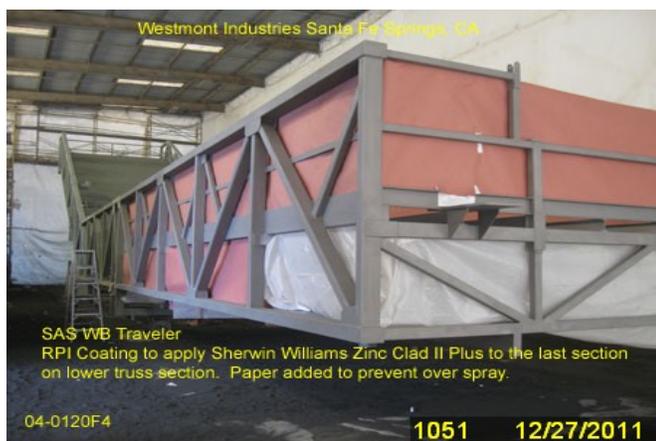
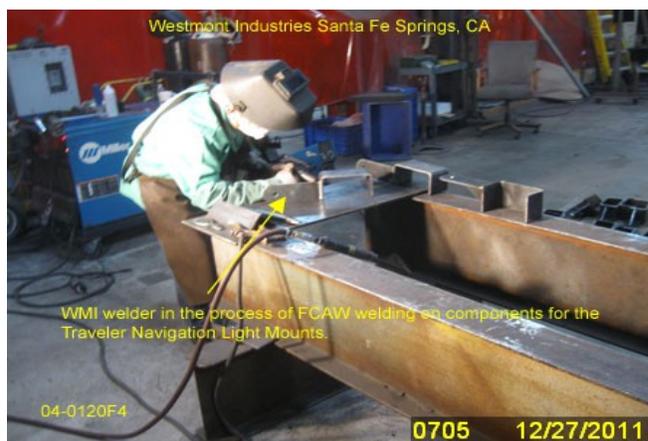
This QA Inspector performed random shop observations and observed that RPI Coating is on site to continue coat applications on the SAS WB Traveler. QA Inspector was informed by RPI Coating Quality Control (QC) Representative Mr. Preston Keen that RPI is going to sweep/spot blast and apply the Sherwin Williams Zinc Clad II prime coating to the last section of the lower truss today. Later in the morning this QA Inspector randomly observed that RPI personnel performing sweep/spot blasting activities on the SAS WB Traveler lower truss section.

After sweep/spot blasting was completed, QA Inspector then observed Mr. Keen performing random surface profile checks on the sweep blasted base metal surfaces. This QA Inspector observed Mr. Keen utilizing a Testex Press-O-Film and a micrometer to perform the testing. During observation, this QA Inspector observed that the readings appeared to be 3.4 mils, 3.5 mils, and 3.5 mils. QA Inspector then observed Mr. Keen perform a test for soluble salts on the previously blasted base metal surface. Testing observed by QA Inspector appears to be in compliance with the contract requirements.

Later in the shift, this QA Inspector randomly observed RPI Coating performing what appeared to be primer application activities within what appeared to be within an 8 hour time frame from the above mentioned sweep blasting activities. Environmental readings taken by RPI at the time of the coating application are as follows Air Temperature 42/72 F, Relative Humidity 61/41%, Wet Bulb Temperature 37/53 F, Dew Point 30/34 F and Surface Temperature 42/64 F.

This QA noted above items observed appear to comply with contract documents.
