Contract #: 04-0120F4Cty: SF/ALA Rte: 80 PM: 13.2/13.9File #: 1x.28**WELDING INSPECTION REPORT****Resident Engineer:** Casey, William**Address:** 333 Burma Road**City:** Oakland, CA 94607**Report No:** WIR-026976**Date Inspected:** 27-Dec-2011**Project Name:** SAS Superstructure**OSM Arrival Time:** 630**Prime Contractor:** American Bridge/Fluor Enterprises, a JV**OSM Departure Time:** 1530**Contractor:** American Bridge/Fluor Enterprises, a JV**Location:** Job Site**CWI Name:** Harry Scharein**CWI Present:** Yes No**Inspected CWI report:** Yes No N/A**Rod Oven in Use:** Yes No N/A**Electrode to specification:** Yes No N/A**Weld Procedures Followed:** Yes No N/A**Qualified Welders:** Yes No N/A**Verified Joint Fit-up:** Yes No N/A**Approved Drawings:** Yes No N/A**Approved WPS:** Yes No N/A**Delayed / Cancelled:** Yes No N/A**Bridge No:** 34-0006**Component:** Bike Path - Skyway**Summary of Items Observed:**

Skyway Portion of the SFOBB: Bike Path at Expansion Joint Hinge "C"

CCO: 193 - Description: Modify the existing bike path panels at the expansion joints of the Skyway portion of the SFOBB East Span Seismic Safety Program.

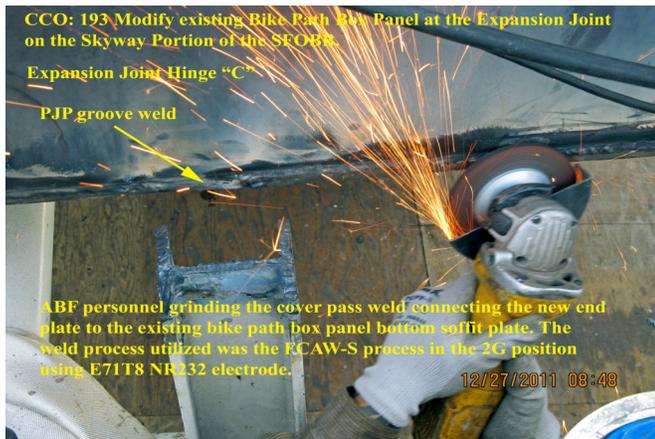
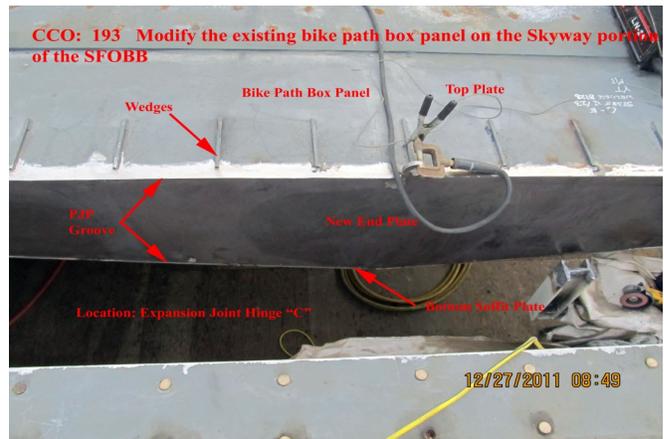
This QA Inspector randomly observed ABF welder Mr. Jason Collins (Welder ID 8128) performing the root, fill and cover pass weld operation on a partial-joint-penetration (PJP) groove weld per the Flux Cored Arc Welding (FCAW-S) self shielding process in the (2G) horizontal position connecting the new end plate to the existing bottom soffit plate of the bike path panel at expansion joint Hinge "C" as per ABF Submittal no. 2549R1 of Contract Change Order (CCO) 193. This QA Inspector observed QC Inspector Mr. Harry Scharein verify prior to the start of the root, fill, and cover pass weld operation that the preheat temperature of 150 degrees F was established and afterwards verified that the welding parameters (Amps, Volts and Travel Speed) were in accordance with ABF-WPS-D15-2160-1 using the E71T8 NR232 electrode - (.072") diameter electrode. The cover pass weld operation was still in-process at the end of this QA Inspectors' shift.

Note: At the Expansion Joint Hinge "C", this QA Inspector previously observed ABF personnel cut back the Top skin plate, Side skin plate and the Diaphragm plate of the bike path box panel using an oxyacetylene cutting torch on a track system and also observed ABF personnel use a mechanical cutting blade on the existing Bottom skin soffit plate of the bike path box panel. The cut back distance was measured at 306 mm as per Contract plan sheet number 1164S8 and ABF Submittal number 2549R1. The new end plate weld operation connecting to the bike path box panel is being performed on this date as mentioned above.
