DEPARTMENT OF TRANSPORTATION

Quality Assurance and Source Inspection

Contract #: 04-0120F4Cty: SF/ALA Rte: 80 PM: 13.2/13.9File #: 82.28**WELDING INSPECTION REPORT****Resident Engineer:** Casey, William**Address:** 333 Burma Road**City:** Oakland, CA 94607**Report No:** WIR-026987**Date Inspected:** 04-Jan-2012**Project Name:** SAS Superstructure**OSM Arrival Time:** 600**Prime Contractor:** American Bridge/Fluor Enterprises, a JV**OSM Departure Time:** 1430**Contractor:** Westmont Industries**Location:** Santa Fe Springs, CA**CWI Name:** Chris Concha**CWI Present:** Yes No**Inspected CWI report:** Yes No N/A**Rod Oven in Use:** Yes No N/A**Electrode to specification:** Yes No N/A**Weld Procedures Followed:** Yes No N/A**Qualified Welders:** Yes No N/A**Verified Joint Fit-up:** Yes No N/A**Approved Drawings:** Yes No N/A**Approved WPS:** Yes No N/A**Delayed / Cancelled:** Yes No N/A**Bridge No:** 34-0006**Component:** Maintenance Travelers**Summary of Items Observed:**

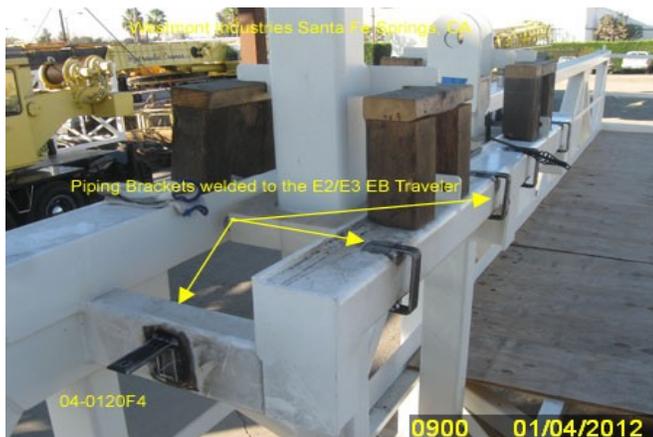
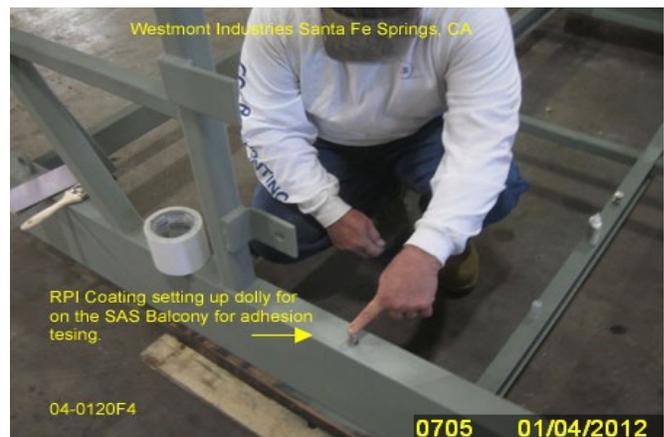
Prime coated on 12-29-11 – SAS Balcony and Anti twist Beams – Adhesion Test – 720 psi and 1200) Pencil Test (pass), Quarter Test (pass) and Rub test (pass).

Testing observed by QA Inspector appears to be in compliance with the contract requirements.
