**DEPARTMENT OF TRANSPORTATION**

Contract #: 04-0120F4Cty: SF/ALA Rte: 80 PM: 13.2/13.9File #: 1.28**WELDING INSPECTION REPORT****Resident Engineer:** Casey, William**Address:** 333 Burma Road**City:** Oakland, CA 94607**Report No:** WIR-027075**Date Inspected:** 25-Jan-2012**Project Name:** SAS Superstructure**OSM Arrival Time:** 700**Prime Contractor:** American Bridge/Fluor Enterprises, a JV**OSM Departure Time:** 1730**Contractor:** American Bridge/Fluor Enterprises, a JV**Location:** Job Site**CWI Name:** Salvador Merino**CWI Present:** Yes No**Inspected CWI report:** Yes No N/A**Rod Oven in Use:** Yes No N/A**Electrode to specification:** Yes No N/A**Weld Procedures Followed:** Yes No N/A**Qualified Welders:** Yes No N/A**Verified Joint Fit-up:** Yes No N/A**Approved Drawings:** Yes No N/A**Approved WPS:** Yes No N/A**Delayed / Cancelled:** Yes No N/A**Bridge No:** 34-0006**Component:** OBG Components**Summary of Items Observed:**

## A). Lifting Lug Holes (SPCM)

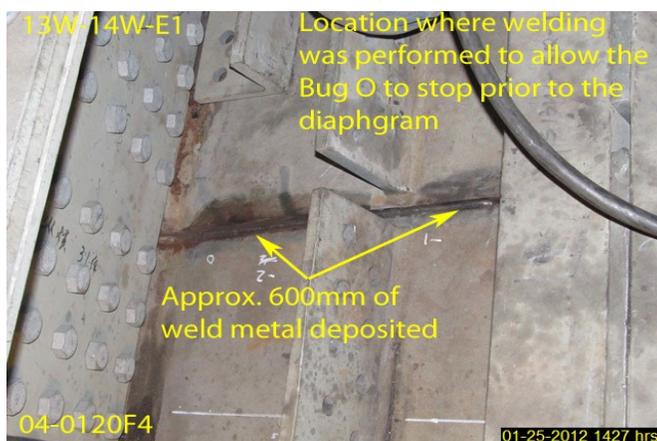
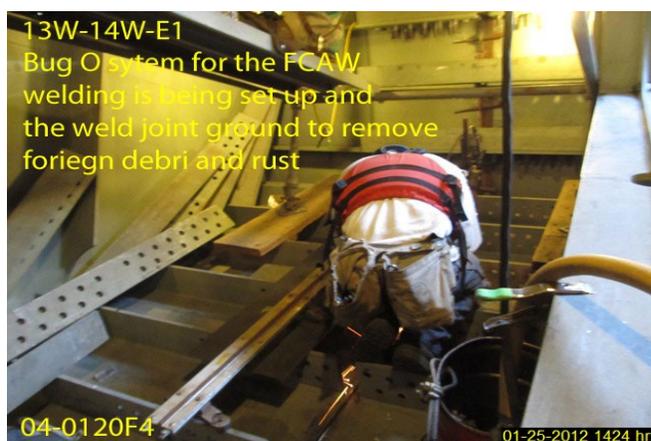
The QA inspector observed the QC activities and the welding utilizing the WPS's as noted above, which appeared to be posted at the weld station. The welding parameters and surface temperatures were verified by the QC inspectors utilizing a Fluke 337 clamp meter for the electrical welding parameters and a Fluke 63 IR Thermometer for verifying the preheat and interpass temperatures. The consumables utilized for the welding process stated appeared to comply with the AWS Specification and AWS Classification. The QC inspection, testing and welding performed on this shift appeared to be in general compliance with the contract documents. At random intervals, the QAI verified the QC inspection, testing, welding parameters and the surface temperatures utilizing various inspection equipment and gages which included a Fluke 337 Clamp Meter and Tempilstik Temperature indicators. Unless noted otherwise, all work observed on this date appeared to be in general compliance with the contract documents at the time of observations.
