DEPARTMENT OF TRANSPORTATION

Quality Assurance and Source Inspection

Contract #: 04-0120F4Cty: SF/ALA Rte: 80 PM: 13.2/13.9File #: 1.28**WELDING INSPECTION REPORT****Resident Engineer:** Casey, William**Address:** 333 Burma Road**City:** Oakland, CA 94607**Report No:** WIR-027123**Date Inspected:** 30-Jan-2012**Project Name:** SAS Superstructure**OSM Arrival Time:** 700**Prime Contractor:** American Bridge/Fluor Enterprises, a JV**OSM Departure Time:** 1730**Contractor:** American Bridge/Fluor Enterprises, a JV**Location:** Job Site**CWI Name:** Salvador Merino**CWI Present:** Yes No**Inspected CWI report:** Yes No N/A**Rod Oven in Use:** Yes No N/A**Electrode to specification:** Yes No N/A**Weld Procedures Followed:** Yes No N/A**Qualified Welders:** Yes No N/A**Verified Joint Fit-up:** Yes No N/A**Approved Drawings:** Yes No N/A**Approved WPS:** Yes No N/A**Delayed / Cancelled:** Yes No N/A**Bridge No:** 34-0006**Component:** OBG Components**Summary of Items Observed:**

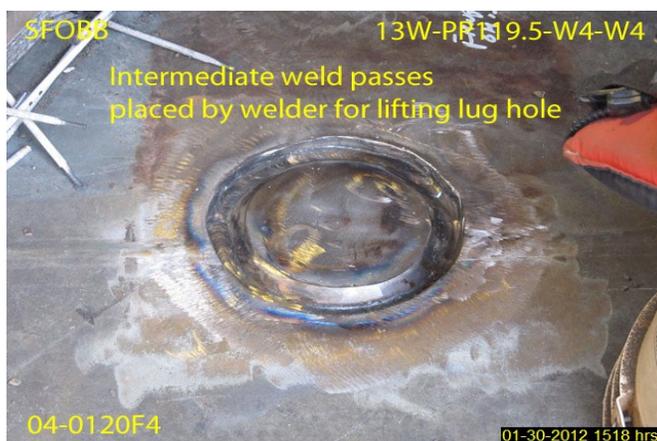
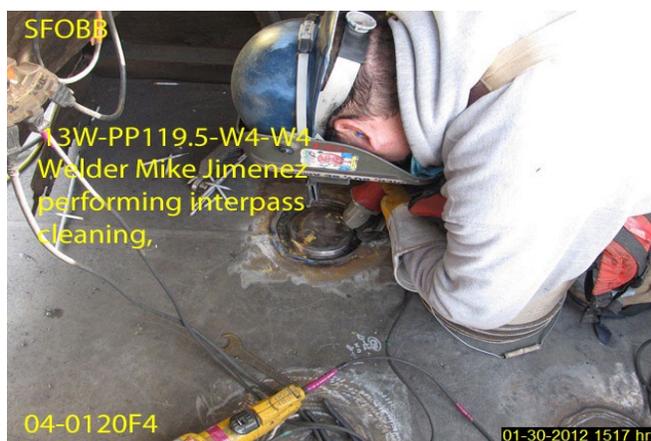
The QA inspector observed the QC activities and the welding utilizing the WPS's as noted above, which appeared to be posted at the weld station. The welding parameters and surface temperatures were verified by the QC inspectors utilizing a Fluke 337 clamp meter for the electrical welding parameters and a Fluke 63 IR Thermometer for verifying the preheat and interpass temperatures. The consumables utilized for the welding process stated appeared to comply with the AWS Specification and AWS Classification. The QC inspection, testing and welding performed on this shift appeared to be in general compliance with the contract documents. At random intervals, the QAI verified the QC inspection, testing, welding parameters and the surface temperatures utilizing various inspection equipment and gages which included a Fluke 337 Clamp Meter and Tempilstik Temperature indicators. Unless noted otherwise, all work observed on this date appeared to be in general compliance with the contract documents at the time of observations.
