Contract #: 04-0120F4Cty: SF/ALA Rte: 80 PM: 13.2/13.9File #: 1.28**WELDING INSPECTION REPORT****Resident Engineer:** Casey, William**Address:** 333 Burma Road**City:** Oakland, CA 94607**Report No:** WIR-027147**Date Inspected:** 06-Feb-2012**Project Name:** SAS Superstructure**OSM Arrival Time:** 700**Prime Contractor:** American Bridge/Fluor Enterprises, a JV**OSM Departure Time:** 1730**Contractor:** American Bridge/Fluor Enterprises, a JV**Location:** Job Site

WELDING INSPECTION REPORT

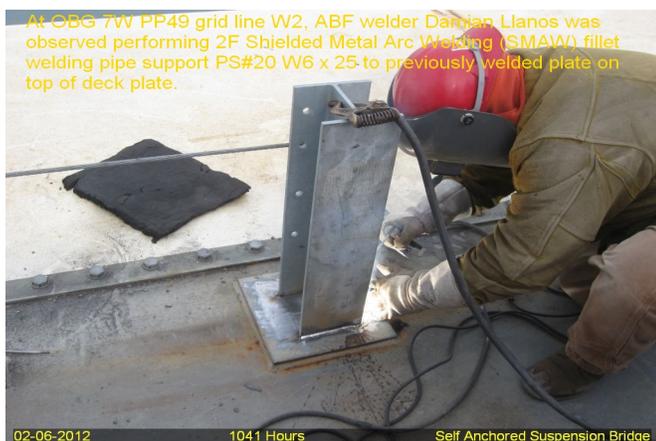
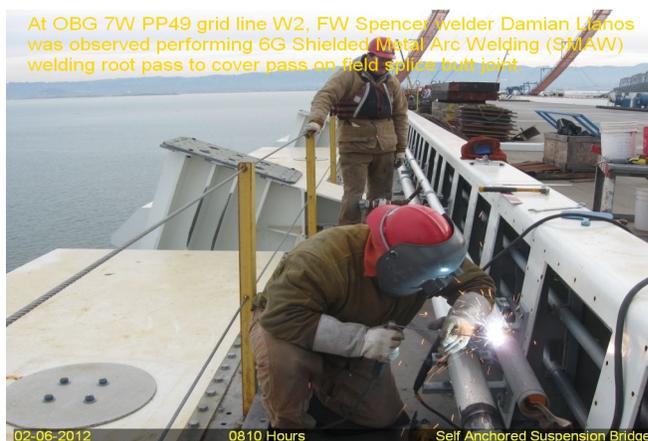
At OBG 7W location Panel Point PP49 grid line W2, this QA randomly observed FW Spencer qualified welder Damian Llanos perform Complete Joint Penetration (CJP) 6G (all position) Shielded Metal Arc Welding (SMAW) welding root pass to cover pass on the field splice butt joint of 2.5" and 4" domestic water and compressed air lines respectively. The system lines being welded are field weld joints of expansion joints along the grid line of W2 of the OBG. The welder was noted welding the root pass with 3/32" diameter E6010 electrode and followed by fill pass to cover pass using 3/32" diameter E7018H4R electrode implementing Caltrans approved procedure FW Spencer WPS 1-12-1. The welder was noted preheating and removing the moisture of the joint using a portable propane gas torch prior welding. During welding, ABF QC Steve Jensen was noted monitoring the parameters of the welder.

The welder was also noted welding pipe support PS#20 for the expansion loop. The welder was noted welding at 2F position using Shielded Metal Arc Welding (SMAW) with 1/8" diameter E7018H4R electrode. The QC inspection was performed by Steve Jensen utilizing the Welding Procedure Specification (WPS) identified as Fillet Murex to monitor the fillet welding to verify the welding parameters. At the end of the shift, the welder has completed the splice butt joints and fillet welding of the pipe support at the following;

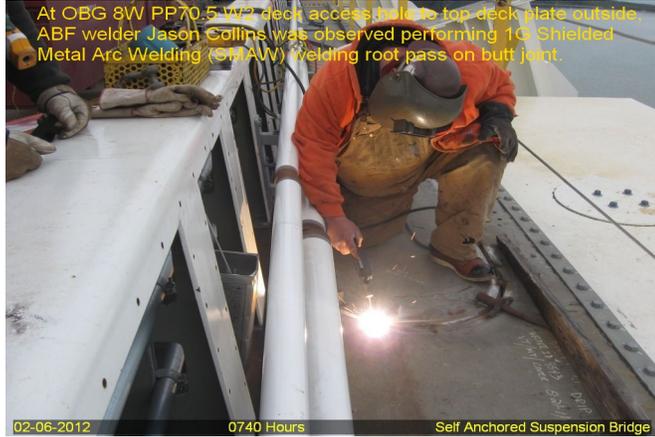
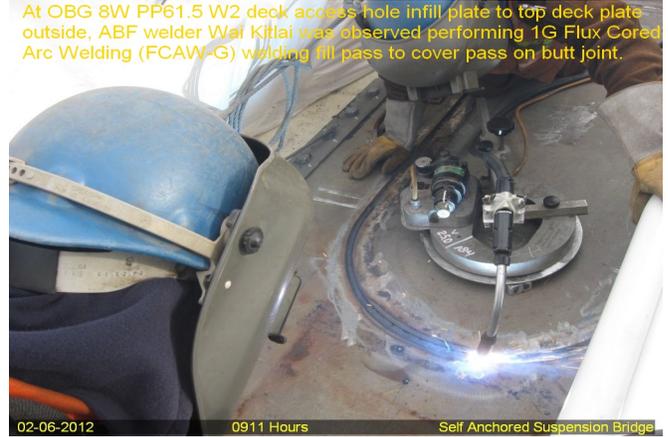
At OBG 8W PP61.5 W2 deck access hole infill plate to top deck plate outside, QA randomly observed ABF/JV qualified welder Wai Kitlai continuing to perform CJP groove welding fill pass then cover pass on the straight and curved radius butt joint. The welder was observed perform automatic welding in the 1G (flat) position utilizing a Bug-o track mounted dual shield Flux Cored Arc Welding (FCAW-G) with E71T-1M, 1/16" diameter wire electrode and implementing Caltrans approved Welding Procedure Specification (WPS) ABF-WPS-D15-3030-1. The joint being welded had a single V-groove butt joint that has been root welded without backing bar. The splice joint was preheated to greater than 150 degrees Fahrenheit using propane gas torch prior welding. During welding, ABF Quality Control (QC) Steve Jensen was noted monitoring the welding parameters of the welder. Measured welding parameters were 225 amperes, 22.3 volts and travel speed of 340mm per minute with calculated heat input of 0.88Kjoules per mm. At the end of the shift, cover pass welding on the curved radius of the butt joint was completed and the straight portion of the joint was still in progress.

At OBG 8W PP70.5 W2 access hole infill plate to top deck plate outside, QA randomly observed ABF/JV qualified welder Jason Collins perform CJP groove root pass welding. The welder was observed welding in the 1G (flat) position utilizing Shielded Metal Arc Welding (SMAW) with 1/8" diameter E7018H4R electrode implementing welding procedure ABF-WPS-D15-1010 Revision 1. The joint being welded has a double V-groove butt joint. ABF Quality Control (QC) Jesse Cayabyab was noted monitoring the welding parameters of the welder.
