Contract #: 04-0120F4Cty: SF/ALA Rte: 80 PM: 13.2/13.9File #: 1.28**WELDING INSPECTION REPORT**

Report No: WIR-027182
Date Inspected: 11-Feb-2012

Project Name: SAS Superstructure **OSM Arrival Time:** 700
Prime Contractor: American Bridge/Fluor Enterprises, a JV **OSM Departure Time:** 1530
Contractor: American Bridge/Fluor Enterprises, a JV **Location:** Job site

CWI Name:	C. Storer, S. Merino, F. Von Hoff			CWI Present:	Yes	No	
Inspected CWI report:	Yes	No	N/A	Rod Oven in Use:	Yes	No	N/A
Electrode to specification:	Yes	No	N/A	Weld Procedures Followed:	Yes	No	N/A
Qualified Welders:	Yes	No	N/A	Verified Joint Fit-up:	Yes	No	N/A
Approved Drawings:	Yes	No	N/A	Approved WPS:	Yes	No	N/A
				Delayed / Cancelled:	Yes	No	N/A
Bridge No:	34-0006			Component:	OBG 13/14 W and 13/14E

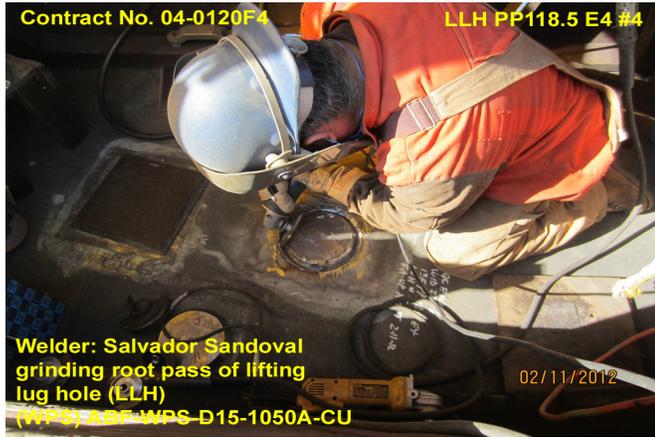
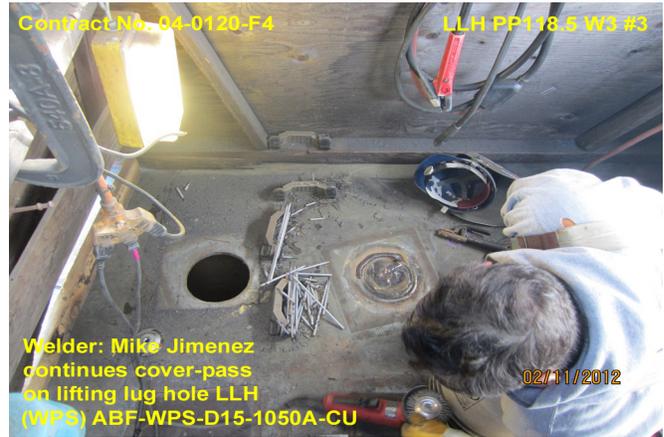
Unless noted otherwise, all work observed on this date appeared to be in general compliance with the contract documents at the time of observations.
