Contract #: 04-0120F4Cty: SF/ALA Rte: 80 PM: 13.2/13.9File #: 1.28**WELDING INSPECTION REPORT**

Report No: WIR-027214
Date Inspected: 21-Feb-2012

Project Name: SAS Superstructure
Prime Contractor: American Bridge/Fluor Enterprises, a JV
Contractor: American Bridge/Fluor Enterprises, a JV

A). Vent Hole 13E (SPCM)

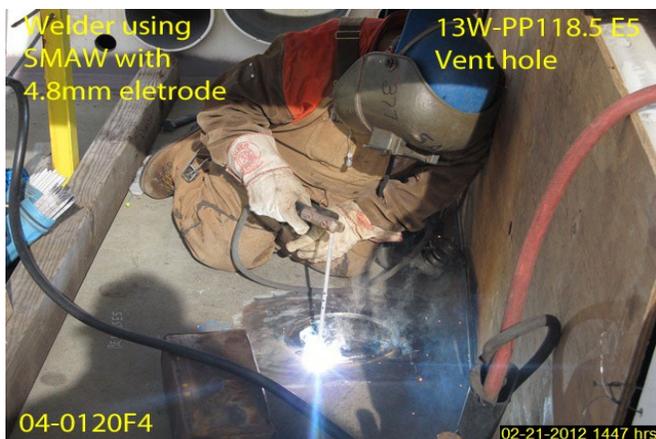
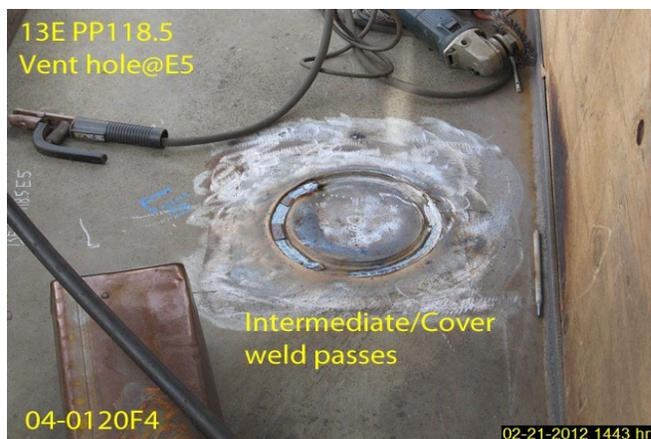
The QAI observed that welder Salvador Sandoval, was using the Shielded Metal Arc Welding (SMAW) process, with electrode E7018 for the Complete Joint Penetration weld in the flat (1G) position at 13E PP118.5 E5 Vent Hole. This QAI observed that a copper plate was used as backing for this location as defined in Welding Procedure Specification (WPS) ABF-WPS-D15-1050A-CU and a 4.8mm electrode was used for the intermediate and cover passes. The welding parameters were verified by this QAI as 252 amps. The welder was observed using a weed burner to pre-heat the area prior to welding at 40 degrees Celsius (150 degrees F) which was verified using a tempstik and infrared gun by the QC. The welder was also observed by this QAI as using a chipping hammer, power grinder and power wire wheel for the interpass cleaning. The QC inspector for this location was Harry Scharein and was observed verifying and documenting the welding parameters for this location, along with overseeing the welding operations. At the time of the observations no issues were noted by the QAI.
