**DEPARTMENT OF TRANSPORTATION**

Contract #: 04-0120F4Cty: SF/ALA Rte: 80 PM: 13.2/13.9File #: 1.28**WELDING INSPECTION REPORT****Resident Engineer:** Casey, William**Address:** 333 Burma Road**City:** Oakland, CA 94607**Report No:** WIR-027221**Date Inspected:** 15-Feb-2012**Project Name:** SAS Superstructure**OSM Arrival Time:** 700**Prime Contractor:** American Bridge/Fluor Enterprises, a JV**OSM Departure Time:** 1730**Contractor:** American Bridge/Fluor Enterprises, a JV**Location:** Job Site**CWI Name:** Salvador Merino**CWI Present:** Yes No**Inspected CWI report:** Yes No N/A**Rod Oven in Use:** Yes No N/A**Electrode to specification:** Yes No N/A**Weld Procedures Followed:** Yes No N/A**Qualified Welders:** Yes No N/A**Verified Joint Fit-up:** Yes No N/A**Approved Drawings:** Yes No N/A**Approved WPS:** Yes No N/A**Delayed / Cancelled:** Yes No N/A**Bridge No:** 34-0006**Component:** OBG**Summary of Items Observed:**

# WELDING INSPECTION REPORT

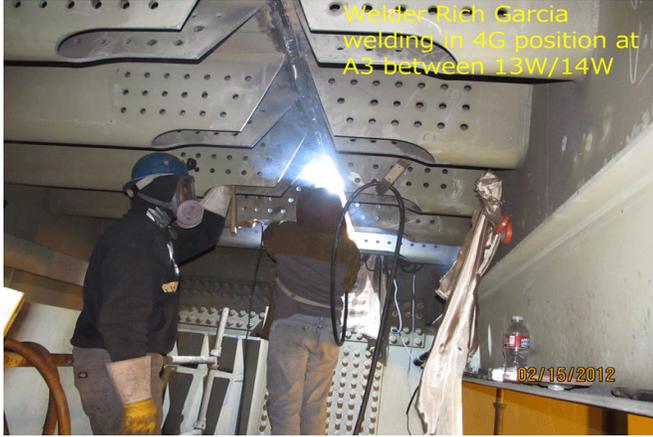
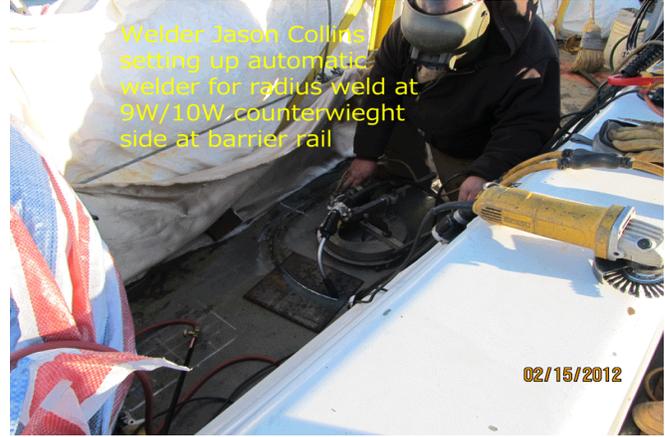
Arc Welding (FCAW) with 1.6mm diameter E71T-1M electrode and implementing Caltrans approved Welding Procedure Specification (WPS) ABF-WPS-D15-1001-4G. This was a Complete Joint Penetration (PJP) weld connecting 13W to 14W side plate to side plate CJP weld A3. This work was located at West line connection joint 13W to 14W.
